Technical Bulletin 77

**AMU Differential Pressure
Silicone Fill Notification**

Totalflow Technical Bulletin

Version 1.0, Revision AA (5 November, 1999)

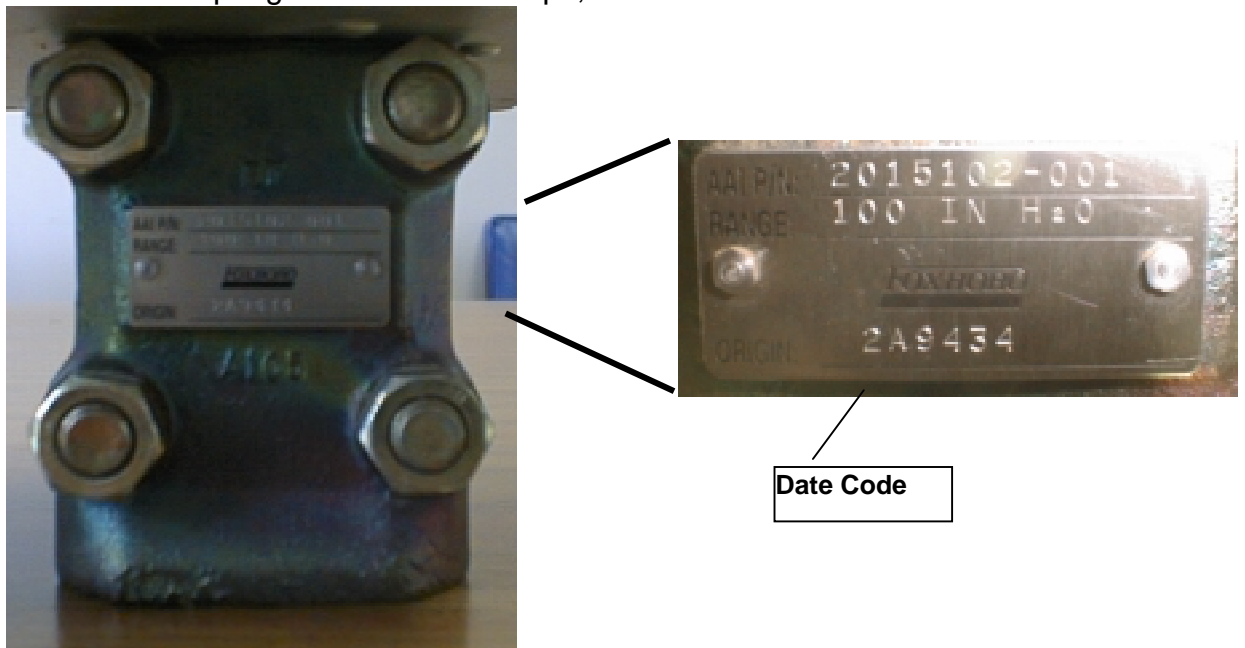
The date code identifier is located on the flange end of the Foxboro DP cell. See picture above. The date code will be a number like “2A9434” where the third and fourth digit represents the year and fifth and sixth digit represents the week. The weld problem could have occurred with the following date ranges:

9622 (22nd week of 1996) through 9837 (37th week of 1998)

Because of the process used, only a small percentage of this lot range will have a problem. In the majority of the lot range, the problem will not exist and will not be covered under warranty.

Foxboro has extended the warranty of the above date code numbers to three years from date of shipment. If you have a unit with the above symptom and date code range, call our customer service group for a return authorization (RA) number. Totalflow will honor Foxboro's extended warranty to our customers for the above date code range. The evaluation process and identification of units with the faulty weld problem has been a lengthy process. Totalflow only recently received a complete date range list from Foxboro. We are confident that the weld problem has been corrected with units produced after the 37th week of 1998.
