TOTALFLOW

Technical Bulletin 160

# **BTU-8000/8100 Analog Controller Module (ACM) Extended Warranty**

Version 1.0, Revision AA (20 March 2008)

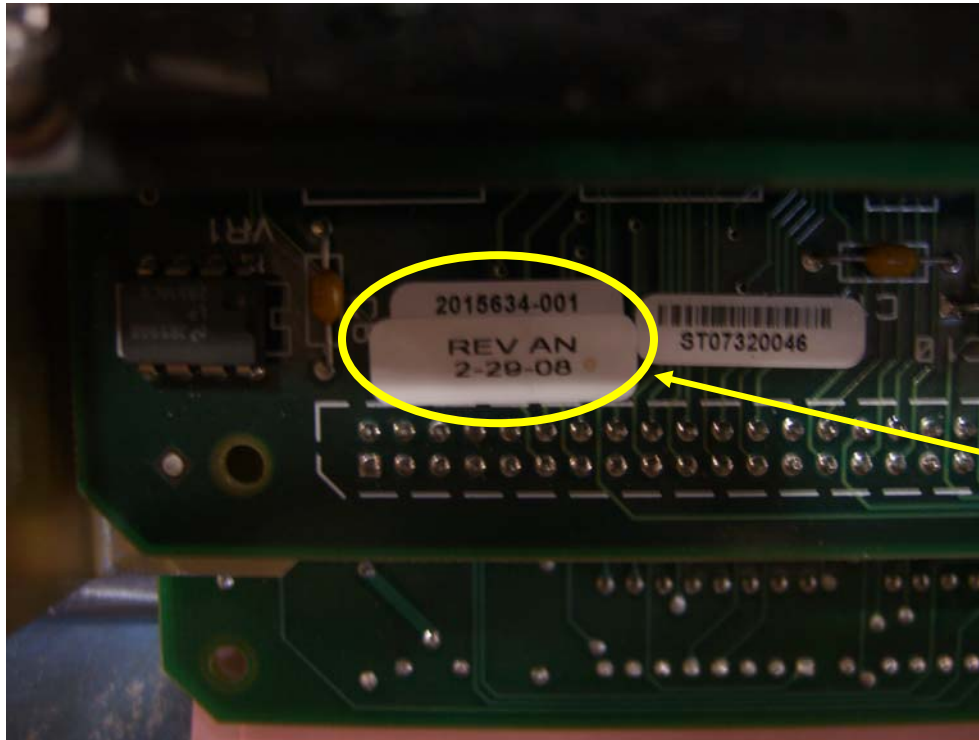
bulletin describes a potential issue with all revision levels “AM” or earlier (see drawing below for revised revision level number). These fuse issues have been resolved with revision level “AN” or later.

Revision level “AN” or later includes all updates described in this bulletin

ABB is providing a volunteer recall for any ACM with revision level “AM” or earlier. ABB will update or exchange any ACM with revision level “AM” or earlier through December 31<sup>st</sup> 2009. This recall time extension is designed to allow you to replace the ACM during a normal preventive maintenance trip instead of an unscheduled site visit. We apologize for any inconvenience this may cause you and your company! The repaired or exchanged ACM per this document will be warranted for 12 months from date of repair or exchange. Please contact Order Entry at (800) 442-3097 option 1 and refer to “technical bulletin 160” for your ACM repair or exchange.
