Technical bulletin 197 μFLO^{G4} and XFC^{G4} 6200/6201EX system reset and RTD input performance deviation

Totalflow products	Doc name: Technical bulletin 197
File name: 2104820TBAB-TB197.docx	Document Title: μFLO ^{G4} and XFC ^{G4} 6200/6201EX system resets and RTD input performance deviation
Distribution: External public	Issued by department: Totalflow customer service
Date: 3/14/2013	Language: En
Revision: AB	Creator name: USJAEST
Page: 1/24	Contact: +1 918.338.4888 or 800.442.3097 (opt. 2)
Status of document: Released

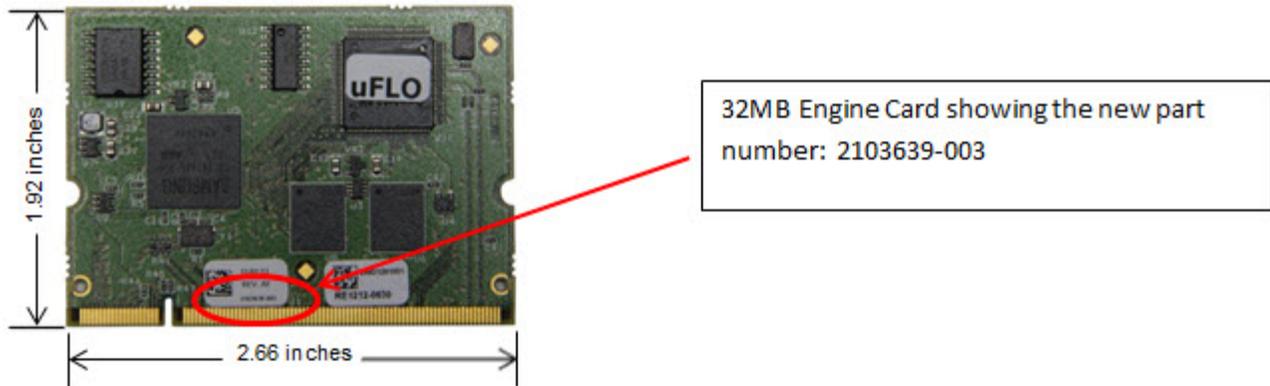
The voltage regulator was replaced on the 32MB engine card. The modified engine card has been thoroughly tested over temperature and does not exhibit the voltage drop at reduced operating temperatures that the previously used regulator exhibited. This voltage drop was the root cause of the 32MB engine card system resets that were randomly observed and has been resolved with the newly modified engine card. The new engine card may be identified by part number 2103639-003 or greater on the card itself. Each card will also have a sticker indicating the hardware platform that it is designed for. The new engine shown card below reflects that it is the new part and is for a μFLO^{G4}.

The software (operating system and flash) has also been updated and is installed on the appropriate engine cards. Users will be able to identify any units that may have this upgrade installed by referring to the attached sticker and verifying the part number to be 2103639-003 or greater.

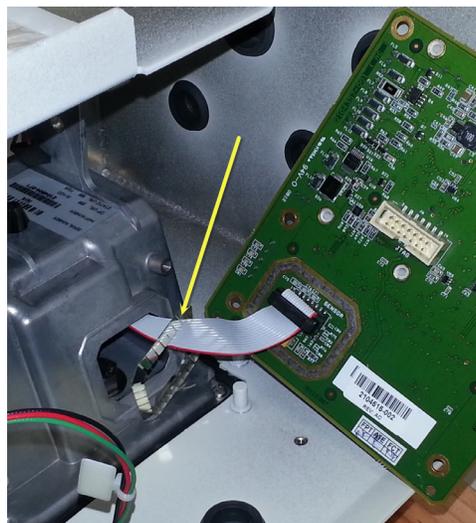
5. Upon removal of the board, you may find 2 conditions that need to be corrected.
 - a. The EMI shield may be loose. This must be repositioned and snapped into place. Improper or incomplete installation of the gasket may result in shorting of components on the board, causing invalid readings for any or all DP, SP, and RTD values. This could also result in the permanent failure of this board.

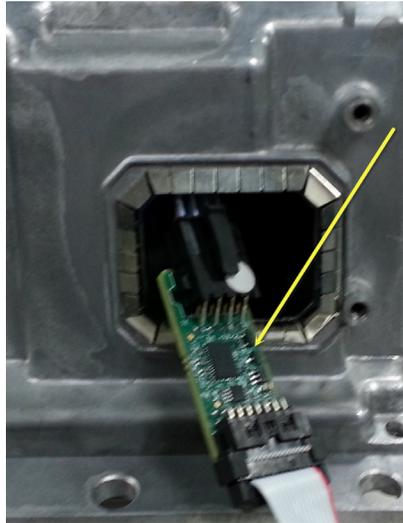
- b. The Stamp Card may have come loose from its internal retaining clip. If this is the case then follow step 6; otherwise, proceed to step 7. If the half round clip is still attached to the loose board it may be very carefully removed so as not to damage the board or its components and may be discarded prior to step 7.

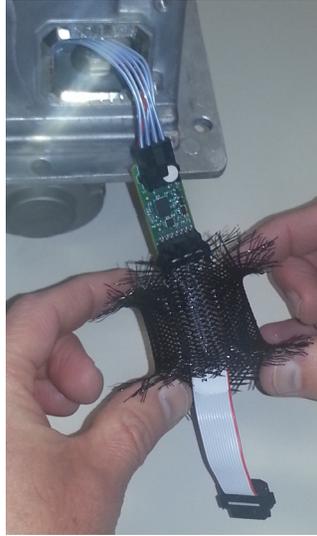
6. If this board is found free from its internal clip, the board may short against the case which could cause continuous restarts, with the LCD displaying a variety of messages including "Totalflow 32 bit XSeries NAND Boot Loader", "Totalflow Launching Windows CE", "Totalflow G4FC OS Part Number <part number>", "Totalflow EXE Startup EXE Part Number <part number>", and sometimes Station ID.
 - a. Make sure the connectors are securely seated. Loose connectors may cause similar symptoms. Apply the protective sleeve supplied with the cable.
