Replacement procedures for modules with incorrect firmware TFIO Analog Input (AI) modules with part number 2100418-009

NOVEMBER 20, 2023 | 2108612TB-TB228

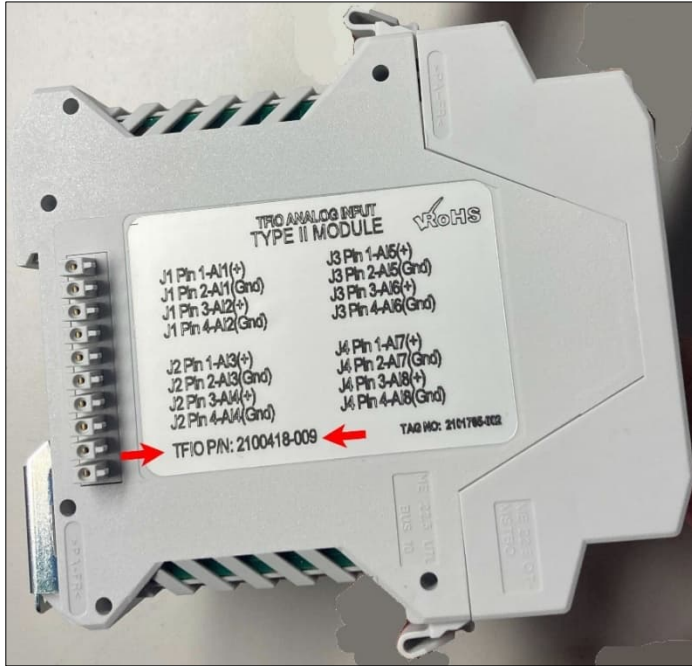
Figure 2-1: Part number on housing: 2100418-009

[Figure 2-1](#) and [Figure 2-2](#) show the location of the part numbers on the housing and on the circuit board. Modules and boards with these part numbers may be configured with the incorrect firmware and must be verified (see section [2.2](#)).
