TOTALFLOW

Technical Bulletin 121

Older Vintage AMU's not Compatible with XFC Flow Computers

Version 1.0, Revision AA (3 November 2004)

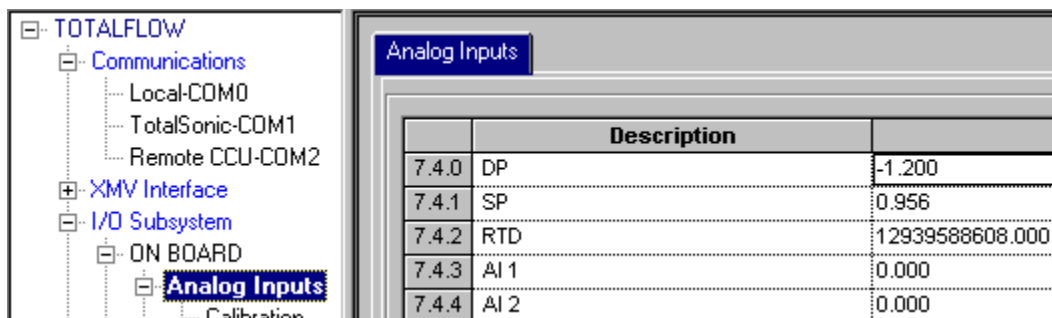
The Flow computer will produce an A/D error and will display and record erroneous differential pressure, static pressure and temperature results. We tested AMU serial number 1104, which produced the following results: Results could vary.

Analog Inputs		
	Description	
7.4.0	DP	-1.200
7.4.1	SP	0.956
7.4.2	RTD	12939588608.000
7.4.3	AI 1	0.000
7.4.4	AI 2	0.000

Install a new FLASH into the Xseries electronic board to resolve the problem.

ABB has corrected this problem by modifying the XFC FLASH image to understand the old AMU data structure. This change makes the XFC board both backward and forward compatible with all AMU and XIMV transducers.

XFC 6400 and 6700 (2100204-00x) FLASH = 2101050-015 or later
