ELSP SAFETY PRODUCTS

# Product change notification

## Tina info output delay

PCN Document No.	2TLC010034J0201	Date of PCN:	2021-09-27
PCN issued by:	Elias Agrell	PCN valid as of:	2022-01-01
Product Manager:	Gustav Örnstedt	Obsolescence Date:	
R&D Manager:	Lars-Magnus Felth	Change Date:	2022-01-01
Products impacted:	Tina 3, Tina 7		
Impact on Form/Fit/Function:	<input type="checkbox"/> Form <input type="checkbox"/> Fit <input checked="" type="checkbox"/> Fctn	Impact on reliability:	<input type="checkbox"/> Y <input checked="" type="checkbox"/> N

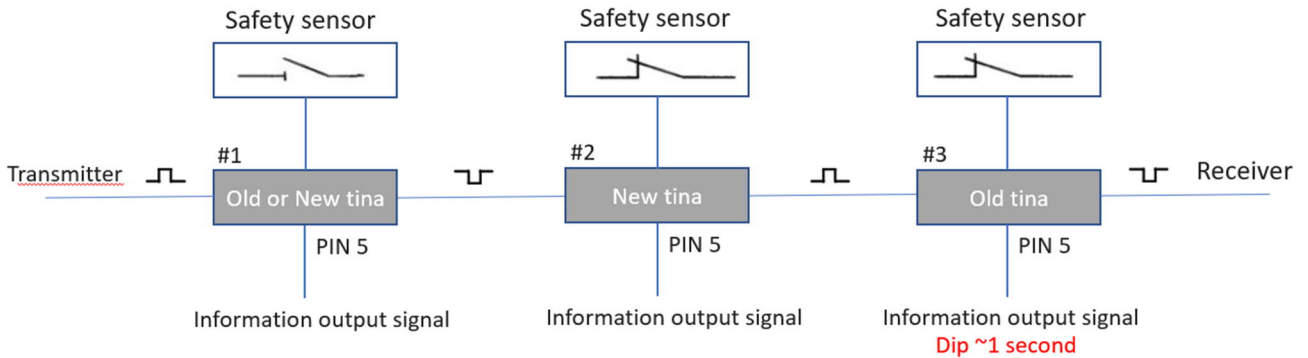
Users of the products can experience that the information output signal goes low for ~1 second despite that the safety sensor is active. This phenomenon can in some cases occur if new products (produced 2022 or after) are mixed with old products (produced before 2022) in the same safety loop.

The phenomenon will occur if a Tina (#1) is deactivated by its safety sensor, which is followed by a new Tina (#2) and an old Tina (#3). Then the old Tina (#3) and the rest (#4 to #30) after in that loop will have the ~1 second dip in the information output signal.

Customers are recommended to analyze the dip/loss off the information signal in their application, when replacing old products with new products. If this behavior affects the application in a negative way can the solution be to:

- Apply a 1,5 second off delay filter on the receiver (e.g., PLC) of the information signal.
- Replace all old products in the safety loop with new products.
- Place all old Tina first in the safety loop, and the new Tina in the end.
