# TOTALFLOW

## *Technical Bulletin 126*

### Switched Voltage battery (Vbatt) Issue on Model 6200 microFLO and XSeries Products

Version 1.0, Revision AA (23 April 2005)

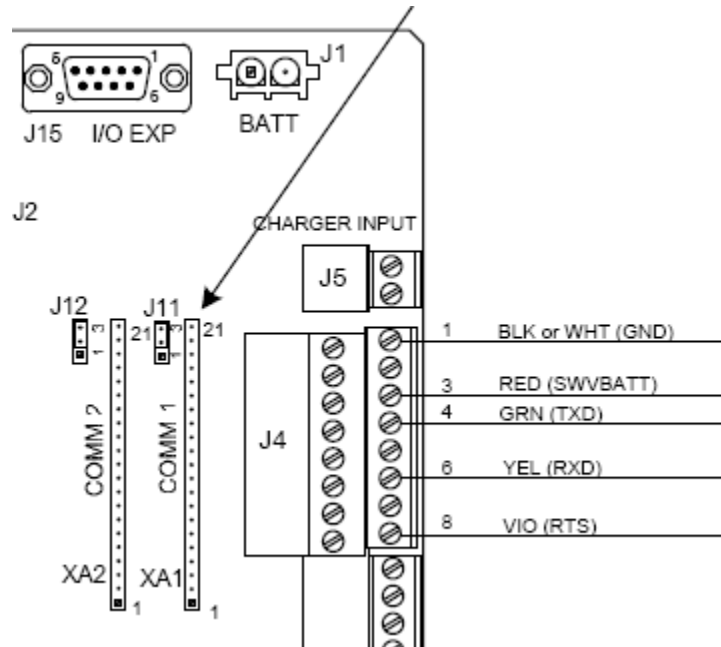
### XFC (P/N 2100204-xxx) Switched Vbatt Signal Diagram

J4 pin 3 = Switched Vbatt for Communications port #1 and port #2
