TOTALFLOW® Technical Bulletin 76

DP Pressure Correction Problem with CB-180 Firmware

Version 1.0, Revision AA (8 January, 2001)

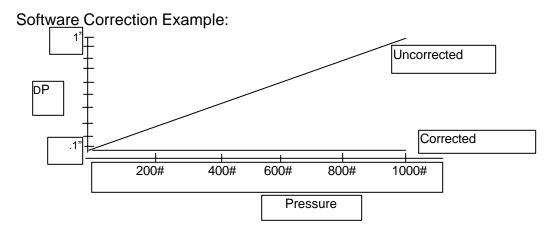
There have been a small number of EPROM's identified that do not provide any DP zero pressure correction. The expected DP zero shift on these units will be based on the transducer manufacturer specifications. As stated above, the DP zero shift specification is 1% per 1000 PSI. The graph above represents the linear shift that will be typical with this problem. The following firmware have been identified with the problem:

Typical errors will be between 0 - 1% of DP range up to 1000 PSI. A maximum error of 2.5% of DP range could be observed with pressures up to 2500 PSI.

If you discover one of the above EPROMs, call our customer service 800 number for a free replacement. The phone number is (800) 442-3097 option 2.
