TOTALFLOW
Technical Bulletin 78

UCI2 Product Update Notice

Version 1.2, Revision AC (10 April, 2000)

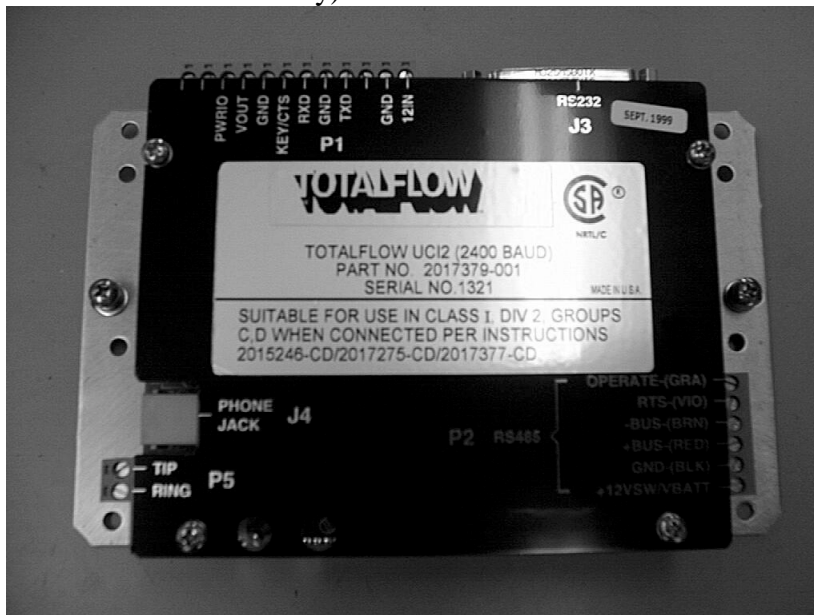
2400 baud modem version shown. Identifiers to distinguish this product from UCI, modem interface, or Datel modems are:

- Phone Jack connector
- Description tag (UCI2)
- Part # 2017379-???

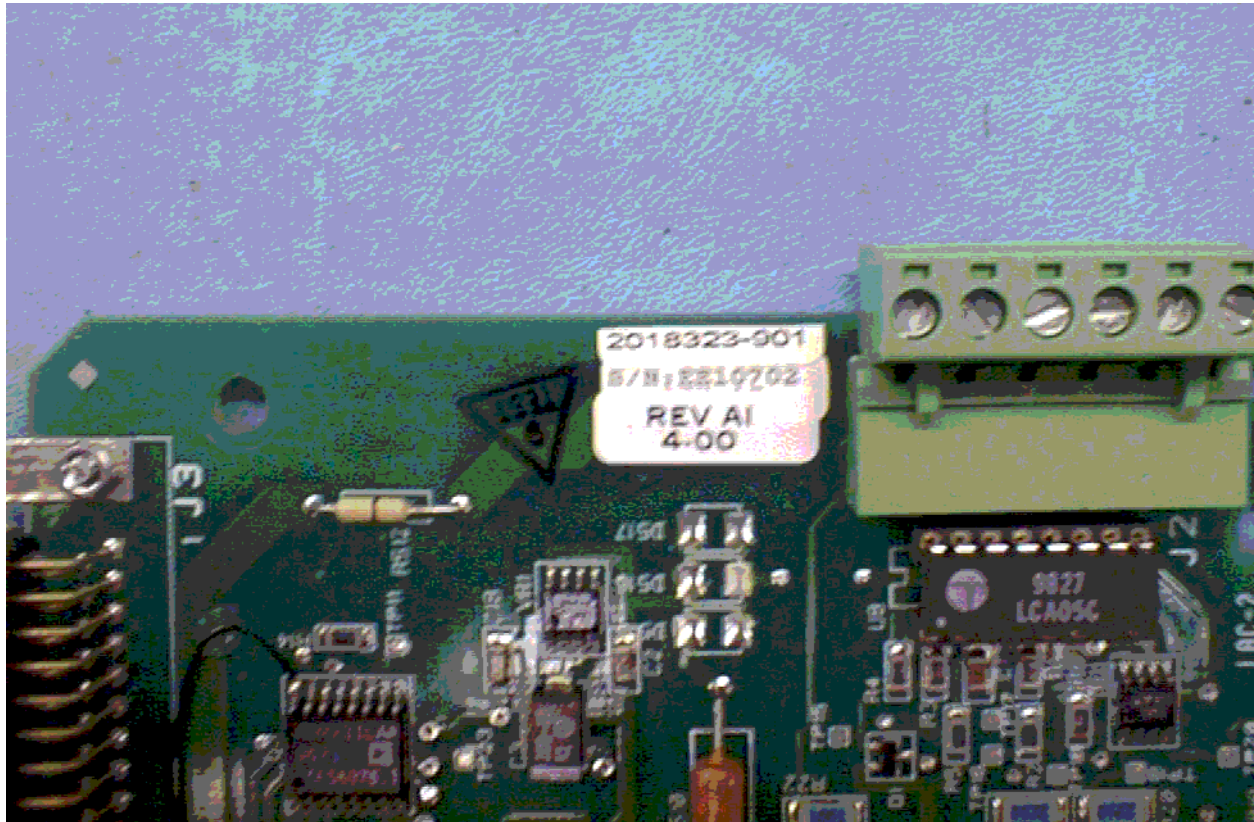
To identify the enhancements, there is a serial number tag and revision On the electronic board (underneath the black top plate). This information will be located on a white tag near the edge of the board. The enhancements described in this bulletin will be on all boards with revision “AI” and higher boards (see close-up picture below). Any revisions from “AH” or below do not have the modem and RS-232 enhancements.

Problems reported on UCI2's without these enhancements have been:

- Phone line will not hang up
- Modem will not answer an incoming phone call
- Modem answers but the Flow Computer will not respond
- Modem will not work with ground wire connected from UCI2 to Flow Computer enclosure
- RS-232 to RS-485 converter works intermittently

To ensure product reliability and customer satisfaction, ABB Totalflow would like to offer an exchange policy for any UCI2's with revision "AG" or lower. For a replacement call (800) 442-3097 and select the ABB Totalflow customer service option on your phone. You will need to have the specific part number of your UCI2 (2017379-001, -002, or -003) before calling. Our service staff will issue you a return authorization number and ship you a replacement. You will have 30 days to return the original UCI2. If the original UCI2 is not received within 30 days, you will be billed for a new unit.
