TOTALFLOW

Technical Bulletin 115

AMU DP Cell Ribbon Cable Notice

Version 1.0, Revision AA (21 January 2004)

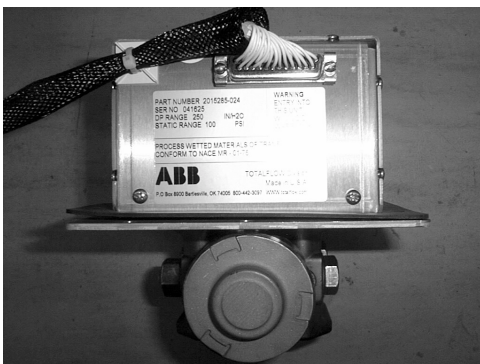
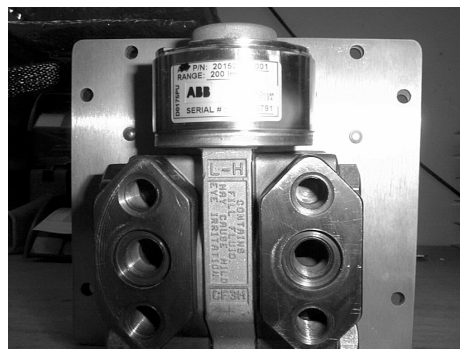
A small number of AMU's (Part Numbers 2015285-xxx, 2015317-xxx, 2015318-xxx, 2015332-xxx, 2015397-xxx, 2017310-xxx, 2017311-xxx, 2018196-xxx, 2018433-xxx) manufactured with DP cell part number 2015214-xxx (see identifying picture below) could have a workmanship issue. Units in question were manufactured from January 1999 through December 2001 and AMU serial number range from 40000 – 71890.

A small quantity of these DP cells had the internal ribbon cable damaged either while in transit or while in inventory waiting to be assembled.

DP measurement will intermittently or permanently overrange to full output (300+ inches of H₂O). This type of symptom could also indicate another type of failure (e.g. DP cell failure). The AMU requires a factory test to determine the exact cause of failure.

Beginning 2/4/2004 ABB will offer to evaluate AMU's with the above DP overrange symptom to determine if your unit has a damaged ribbon cable. If we confirm your unit has a damaged ribbon cable ABB will replace the unit with a refurbished AMU at no charge. Customer is responsible for shipping the unit to Bartlesville, OK. And ABB will pay for the return shipping charges. The refurbished AMU will carry a 3 month extended warranty. If the unit is found to have some other non-related failure then you will be given an opportunity to exchange the defective unit for a refurbished unit at the current exchange price.

If you discover an AMU that displays the symptom listed above ABB will evaluate the returned AMU to determine if it has the ribbon cable defect. Call our Totalflow Customer Service Order Entry group at (800) 442-3097 and request a Return Authorization number. When discussing with Order Entry reference this bulletin number or “Ribbon Cable Defect”. Order Entry will provide packing and shipping instructions. The defective unit will need to be packaged and returned to ABB Totalflow. Please use sufficient packing material to keep the AMU from getting damaged in shipment. It is advisable to use the original AMU box or the replacement AMU box when returning an AMU.
