Lightning incident at Saudi Arabia's first Aluminium Smelter at Ras Al Khair,

Sequence of Events

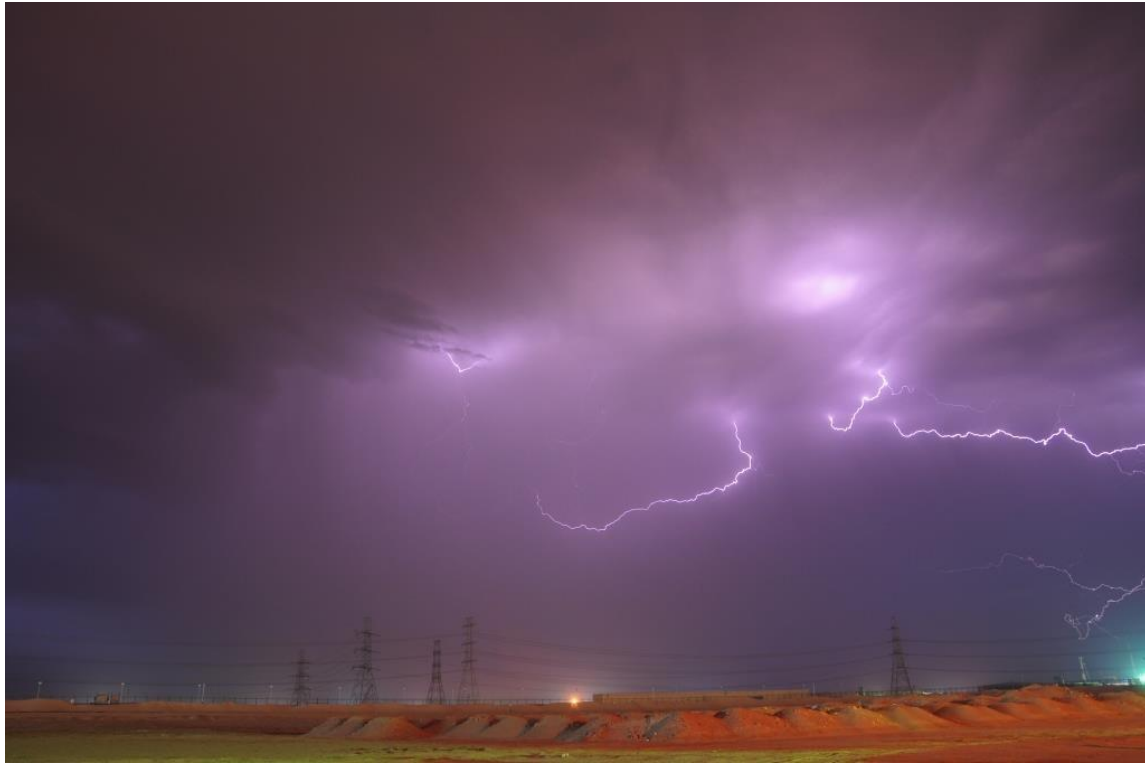
(Picture 1; Ras Al Khair Smelter 380kV Feeder, Lightning strike 23rd March 2013

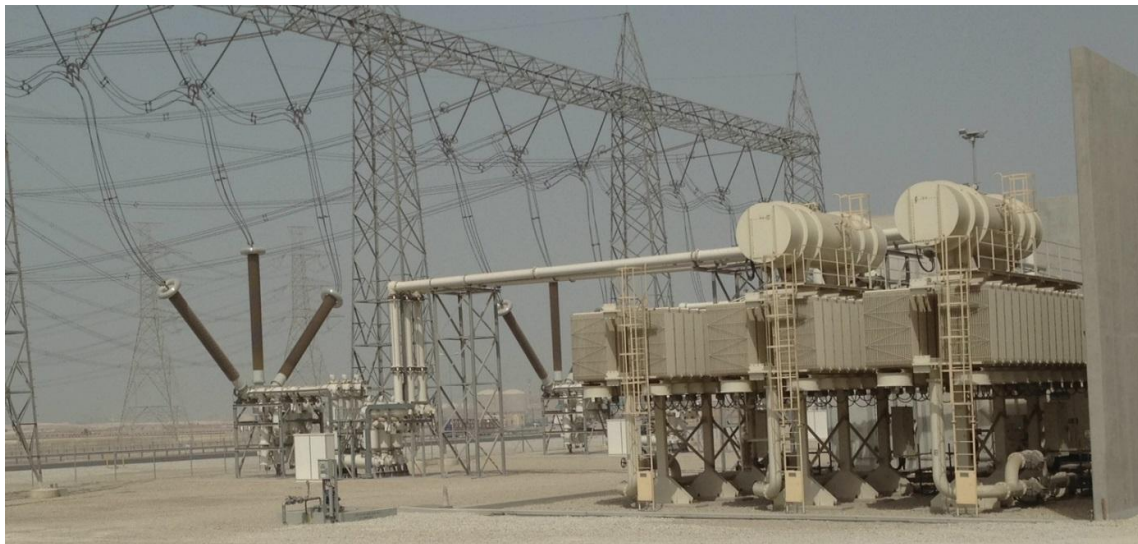
(Picture 2; Ras Al Khair Smelter 380kV Outdoor GIS Incomer from SEC Grid)

The overhead earth wires from the SEC 380kV towers were connected to the landing gantry of the smelter (see picture 2) the height of the gantry lightning poles was not sufficient to cover the transformer tanks completely

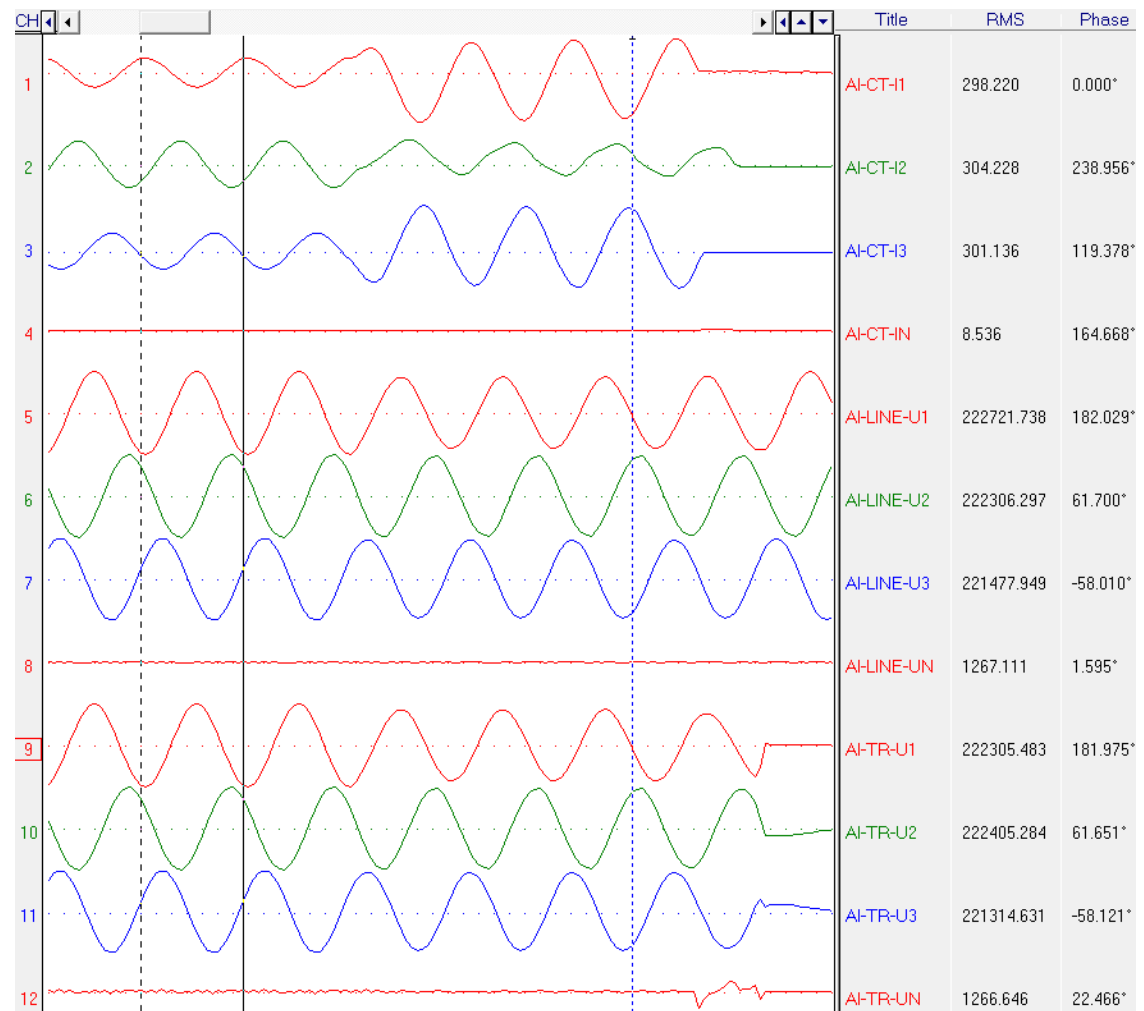
The below screen shot is taken from REC670, which is used as a control IED.

(Intelligent Electronic Device) This relay recorded the transformer feeder currents & voltages as well as the voltages of the Incoming power line.

Figure 1 Differential current protection relays fault recorder read out and tertiary winding arrangement

It appeared that there was no fault on primary or secondary side of transformer. However, it look like that the fault was on the tertiary winding of the transformer. The bushing of tertiary windings are exposed to the environment while almost all other terminals & devices are gas insulated or covered.

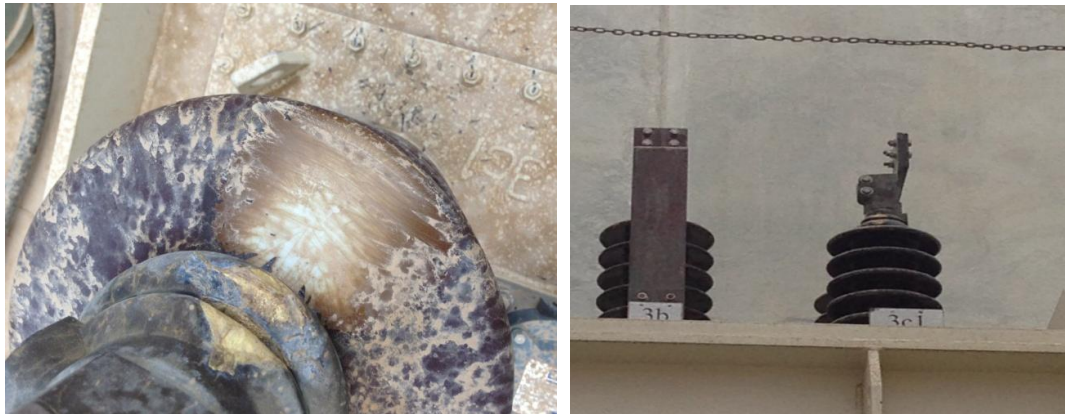
Conclusion was that there had to be a flashover on the tertiary bushings. Site personal were ask to conduct an inspection of the tertiary bushings which later confirmed ABB's study and analyses results.

Damage to the Transformer bushings due to flash over

Picture 3-4 Autotransformer tertiary bushings with flashover

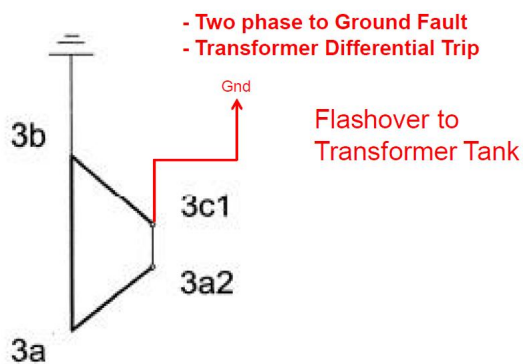
Picture 5 Autotransformer tertiary winding arrangement

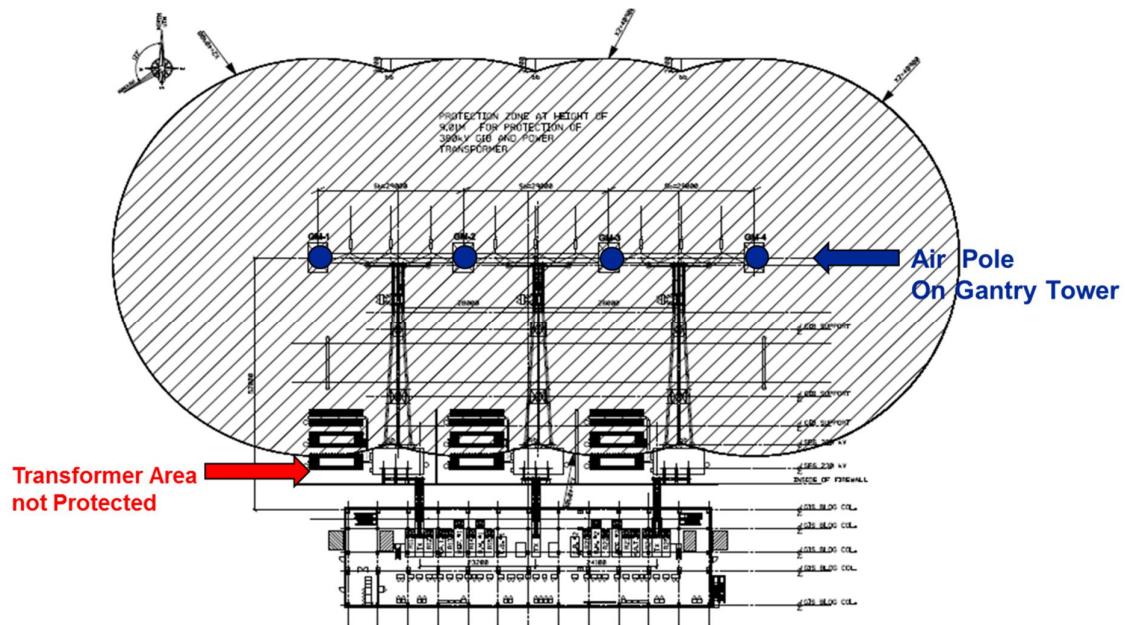
Figure 2 MAC 380/230kV Lightning pole arrangement

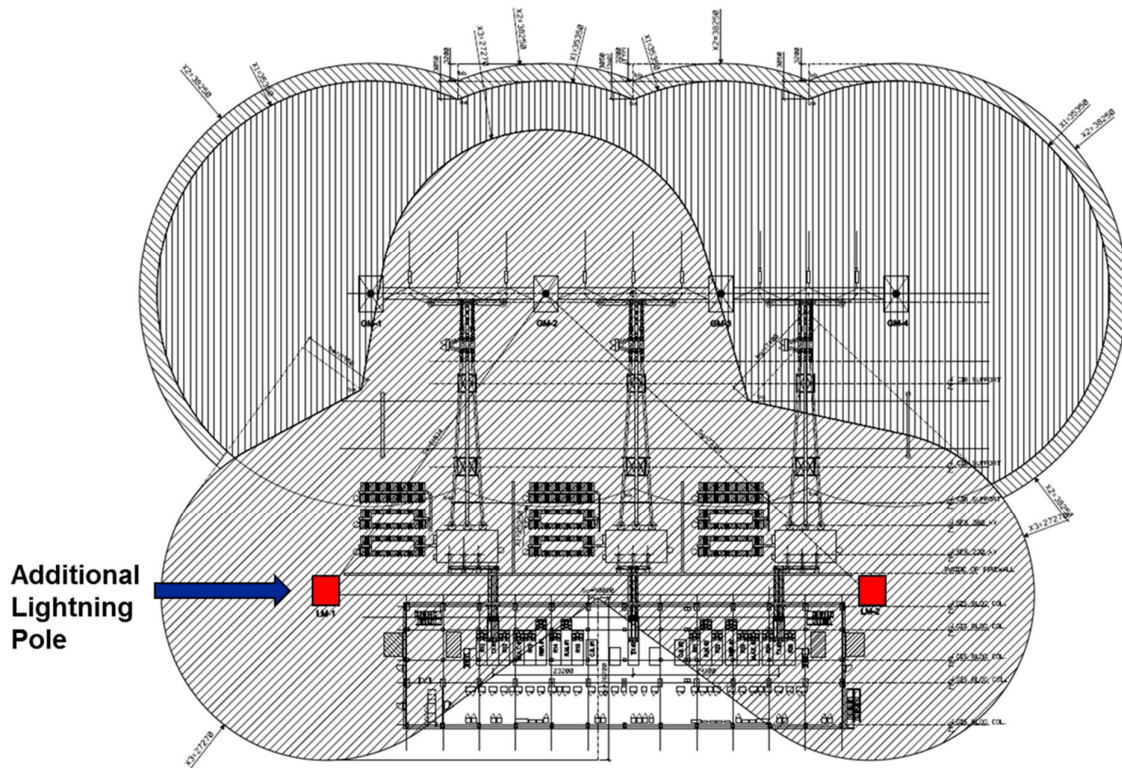
Figure 3 MAC 380/230kV Lightning pole arrangement after ABB conducted a detailed study

Recommendations to improve the Lightning protection:
