Separation of DALI double addresses DG/S x.64.1.1 and i-bus Tool

GPG BUILDING AUTOMATION

Doc.-Type: Step-by-Step Guide

Product: Dali DG/S x.64.1.1 und i-bus Tool

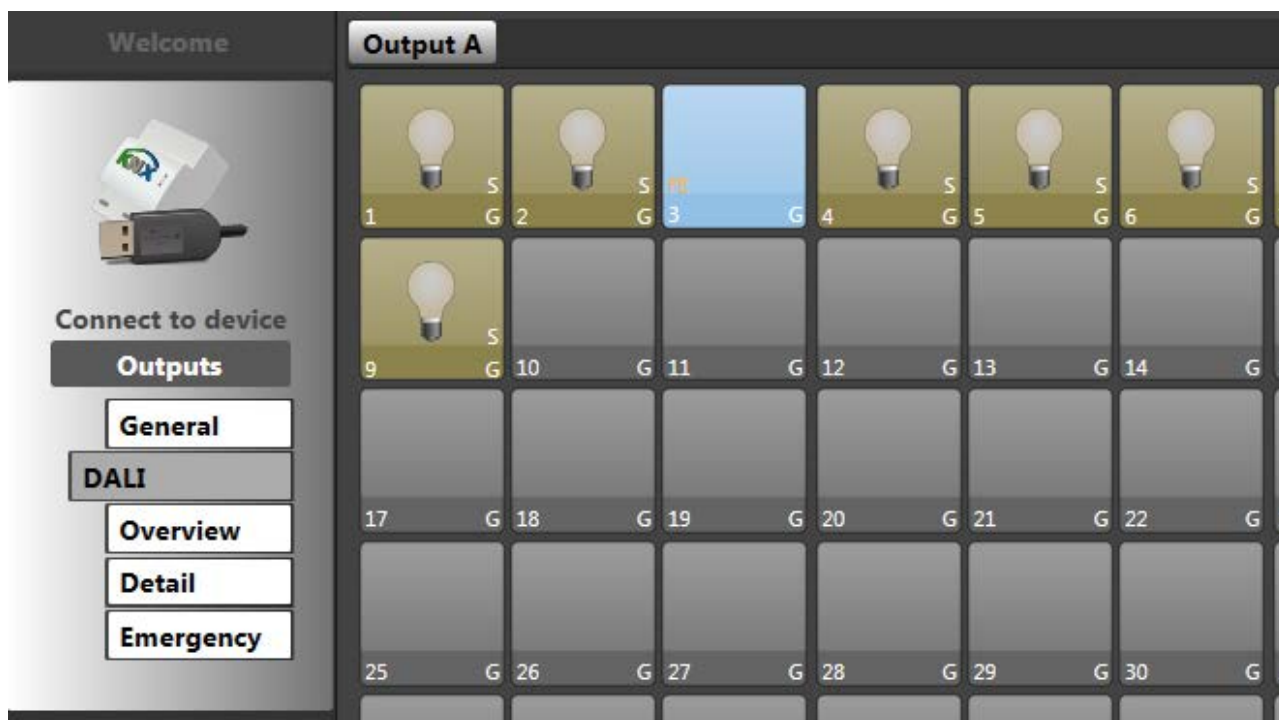
Example: Address 3 is used by two devices, in the i-bus tool address 3 is displayed with FE (Framing Error). If DALI address 3 is selected, the two DALI luminaires with DALI address 3 are switched on.

Since in our example two devices have the same address, two devices answer, which leads to an invalid response telegram, for the DALI Gateway a framing error.

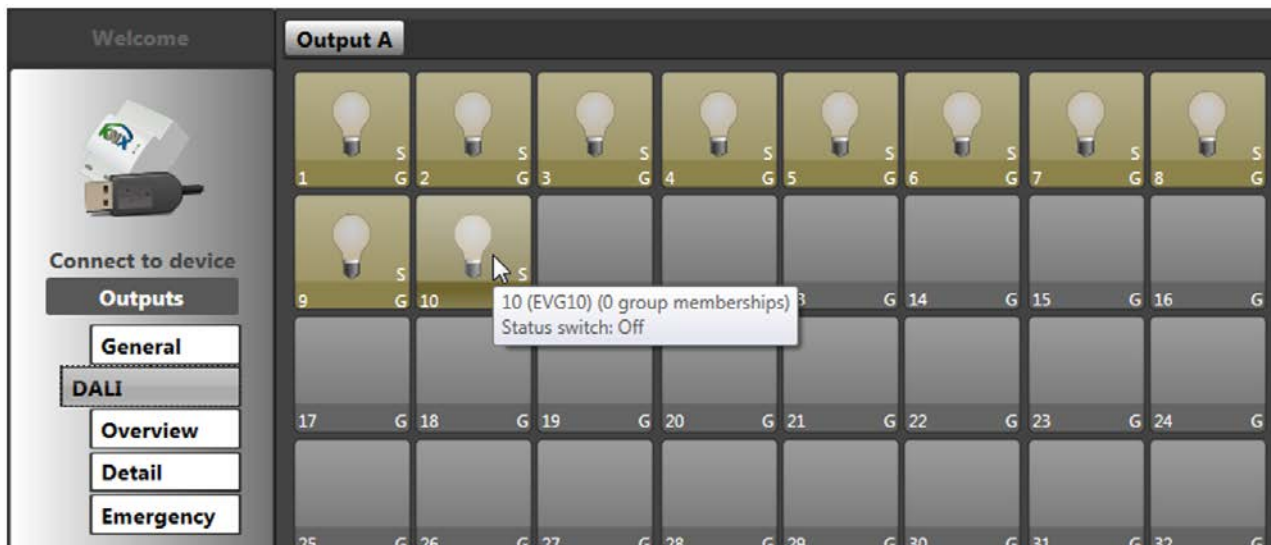
In this example, one of the two doubly addressed ballasts has received the address 10, the other one has still address 3.
