# System 800xA

## Release Notes

## New Functions and Known Problems

System Version 6.0.2

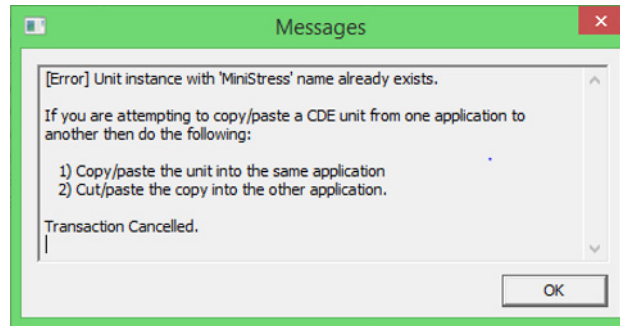
*Figure 8. Error message for duplicate name conflict*

Copy-paste across projects or applications results in a duplicate name conflict generated from the name synchronization aspect. [Figure 8](#) shows an error message that is displayed to users.

Users need to copy-paste the diagram into the same application so that Control Builder M automatically generates a unique name for it and then cut-paste it into the desired application.
