DCS880

Release note

Firmware version: DCSF1x2.07.3.0

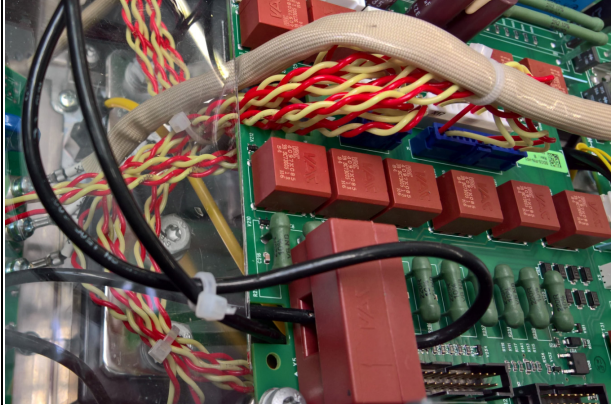
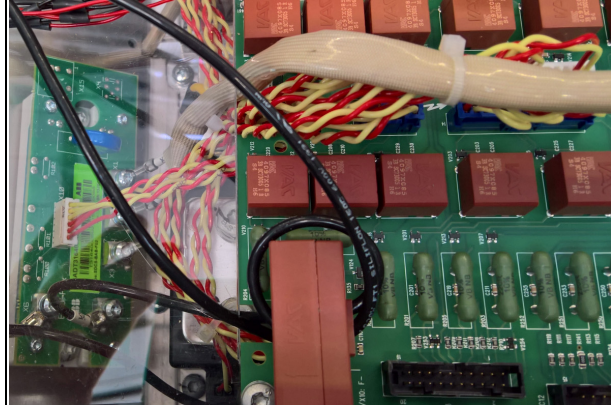
- Armature current autotuning is only possible if the drive is already in ON stage. It is not possible to use Drive Composer entry/pro.
- Speed depending proportional gain and integration time is not working. See parameters 25.18 ... 25.22.
- Torque depending proportional gain is not working. See parameters 25.25 ... 25.27.
- Instable PLL. See parameters 95.39 ... 95.50.
- Changing value of 99.07 M1 used field exciter type needs a power cycle.
- OnBoard field exciter field current measurement corrected for converters size H3 (290 A ... 520 A):

Firmware version 2.02.3.0 or higher	Firmware version 2.01.1.0 or lower
T100 threads: 1 (equals no loop).	T100 threads: 2 (equals 1 loop).

For any firmware update please adapt the T100 threads. Otherwise the field current measurement is incorrect.
