TOTALFLOW Technical Bulletin 122

μ FLO (microFLO)

Local Communications Port Issue Totalflow Technical Bulletin

Version 4.0, Revision AD (2 December 2009)

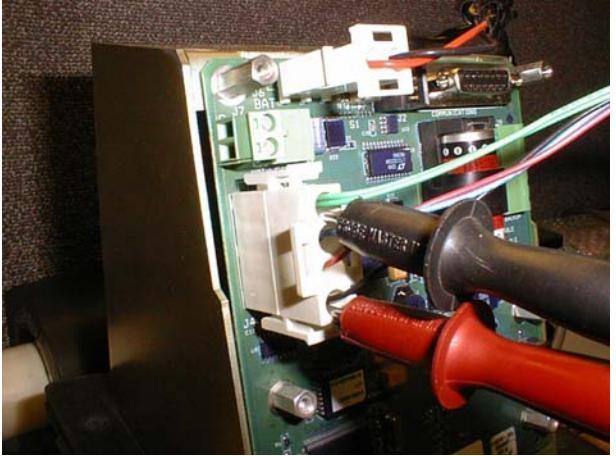
Next, measure between pin 1 and 4 (green wires, pin 4 is ground) with a multimeter set to DC volts. Voltage should be approximately (-)5 vdc to (-) 15 vdc +/-10%

If either voltage measures between (-)2 and 0 vdc then you have a shorted MOV and the board needs to be repaired and upgraded to the –003 revision level.

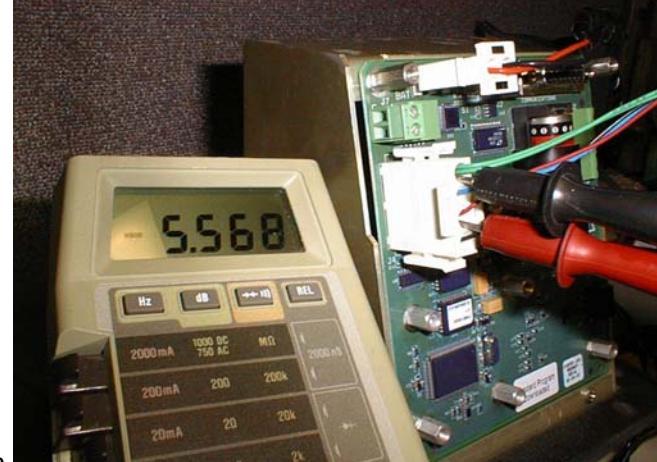
Next, measure between pin 2 and 4 (Red wires, pin 4 Green is ground) with a multimeter set to DC volts. Voltage should be approximately (-)5 vdc to (-) 15 vdc +/-
