Fingerprint analysis

Optimizing boiler efficiency pays off

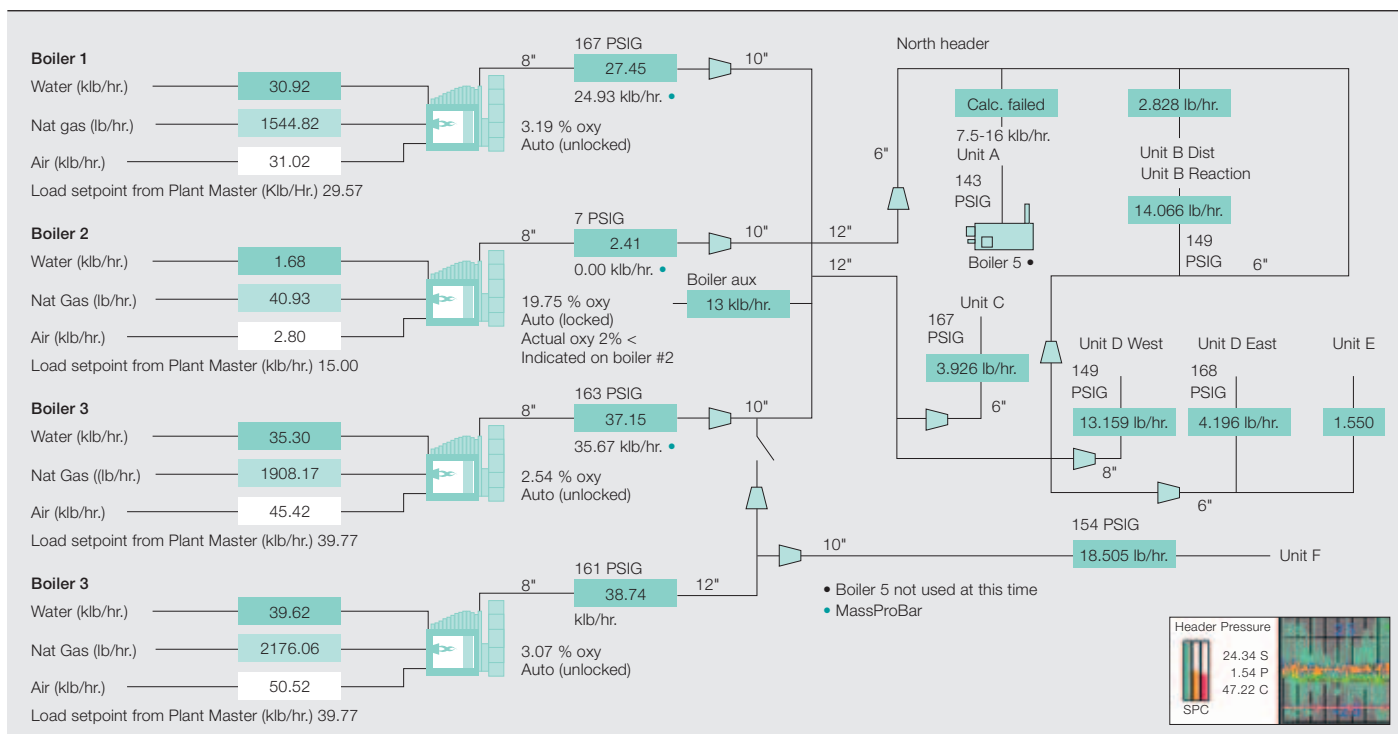
2 The Arkema site schematic

ers, both installed in 1952, are brick-set with forced-draft (FD) intakes and induced-draft (ID) removal fans. Both are rated at 40 klb/hr. The third boiler, a 1965 economizer, has only an FD fan and is rated at 75 klb/hr, though it was typically operated at a maximum of 60 klb/hr.

The fourth boiler, a 1996 economizer, of the flue gas recirculation (FGR) type, was operated identically to the third.

All four boilers produce steam at about 165 psi, but none were run at maximum load. The Fingerprint work began with the second boiler as it is the one used most often and it is the least efficient.

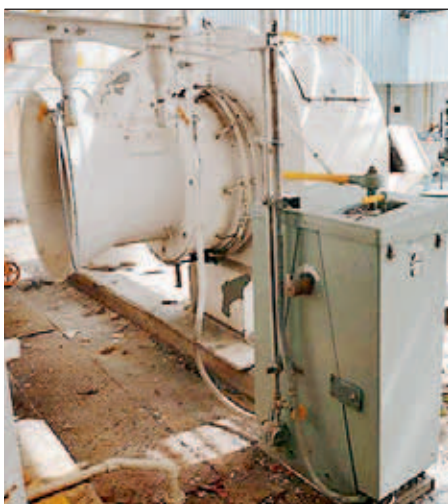
3 The forced-draft fan unit

Initial examination revealed that the ID fan positioner movement was jerky, indicating a potentially faulty pneumatic cylinder or piston assembly. The FD fan was also found to have issues → 3.

The ABB team noticed a loose hatch door near the oxygen sensor that was leaking air into the ductwork before the ID fan. Also, the two boiler oxygen sensors continued to read about 2 percent higher than a portable analyzer.

- Repair FD and ID control drives
- Resolve oxygen transmitter reading issues: check calibration, find leak, change location
- Adequately seal all doors
- Recalibrate steam flows
- Add blowdown flow monitoring (blowdown removes solids buildup originating from the water/steam)

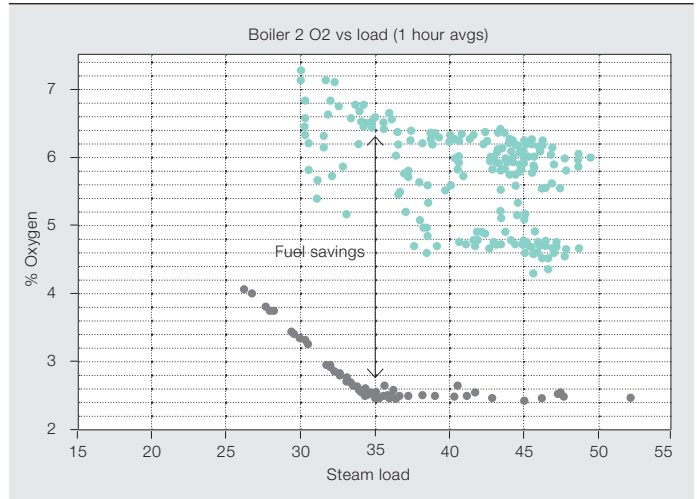
5 Reducing oxygen flow brings significant savings.

As a result of the remedial measures, oxygen readings, which had measured in the 6 to 7 percent range, were brought down to under 5 percent → 5. This reduction in oxygen levels reflects less air

drawn in, less air heated up and less air blown out, resulting in substantial fuel savings.

The approximate value in savings was \$75,000 for the second boiler alone, and all without major capital investment.
