# System 800xA Extensions for Power Generation Utility Library 6.0.4.1– Release Notes

Release: July 2022

Document number: 1KGF101045-6041\_B

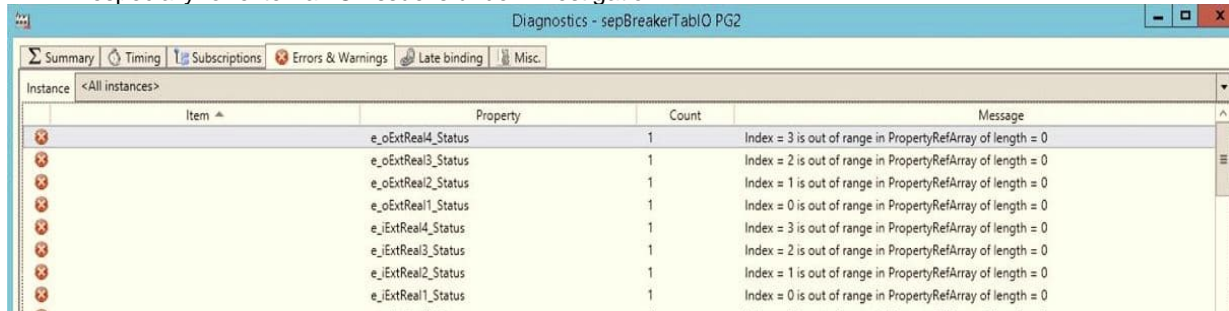
1. TFS Bug 159725: In all the objects where latebinding is used, there are clutter of errors appearing in Diagnostics section of "TabIO" aspect as shown below. It is doubted that this is causing slowness in update of certain symbols especially for external IO. Issue is under investigation.

Solution: Currently no solution is available for this issue for the projects which are using the external IO feature. However, projects not using external IO can be in touch with [in-pw-librarysupport@abb.com](mailto:in-pw-librarysupport@abb.com) for possible solutions.

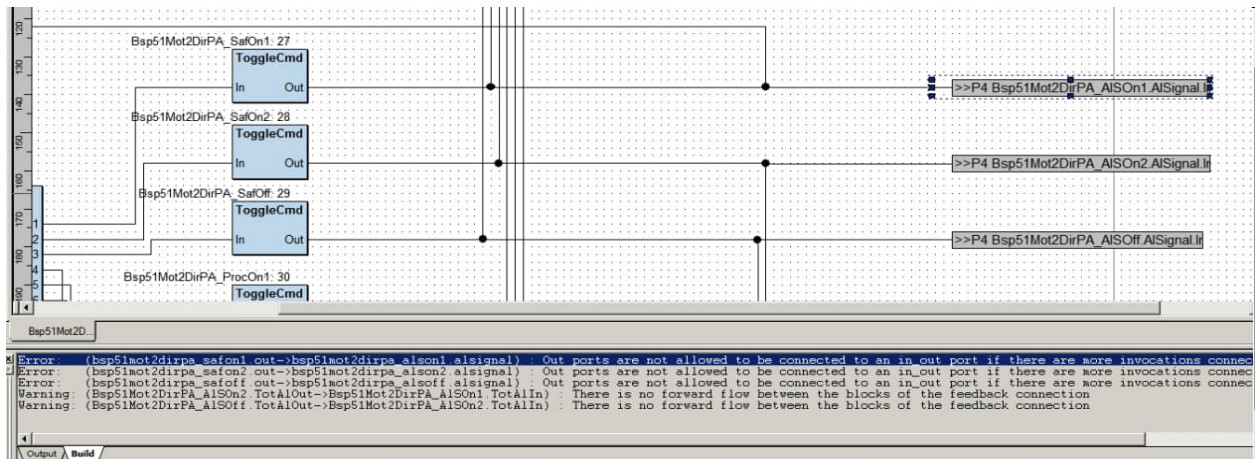
1. "Out ports are not allowed to be connected to an in\_out port if there are more invocations connected to the out port."

Figure 1: Error: "Out ports are not allowed to be connected to an in\_out port if there are more invocations connected to the out port."

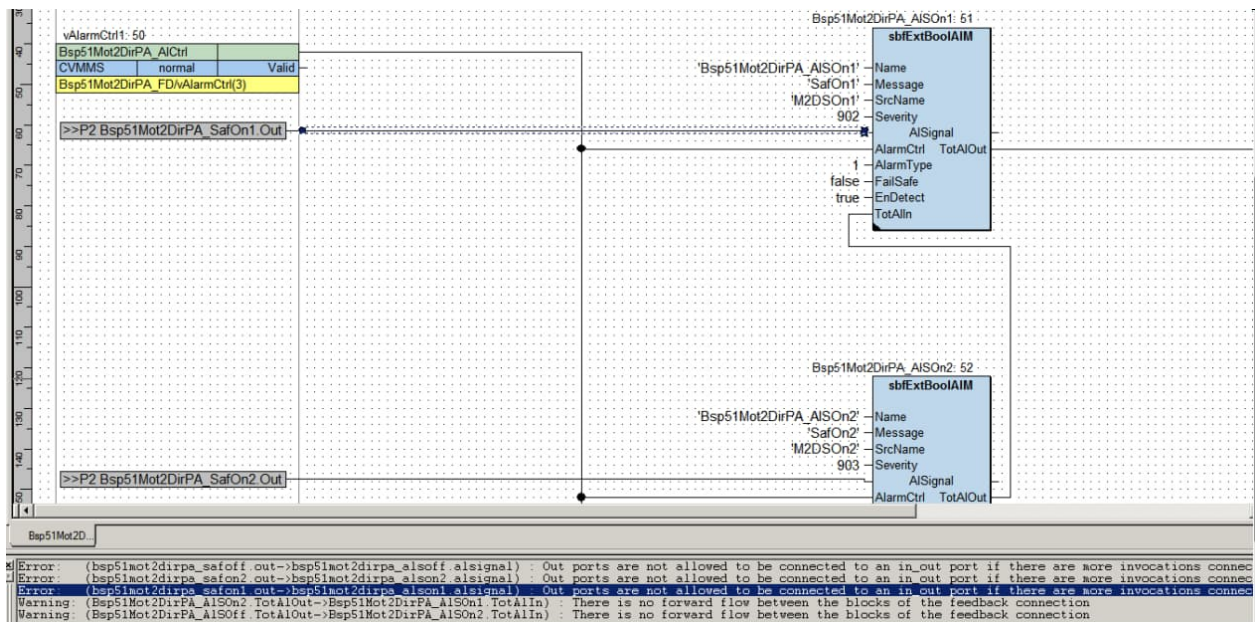
Figure 2: Error: "Out ports are not allowed to be connected to an in\_out port if there are more invocations connected to the out port."

Workaround: Add Variable for Out port and connect to Page connector. Refer Figure 3 to Figure 6 for workaround.
