## APPLICATION NOTE

# Solving FIM issues regarding missing UMC100.3 devices in the topology

Short guide to fix issues related with UMC100.3 not showing up in the topology window

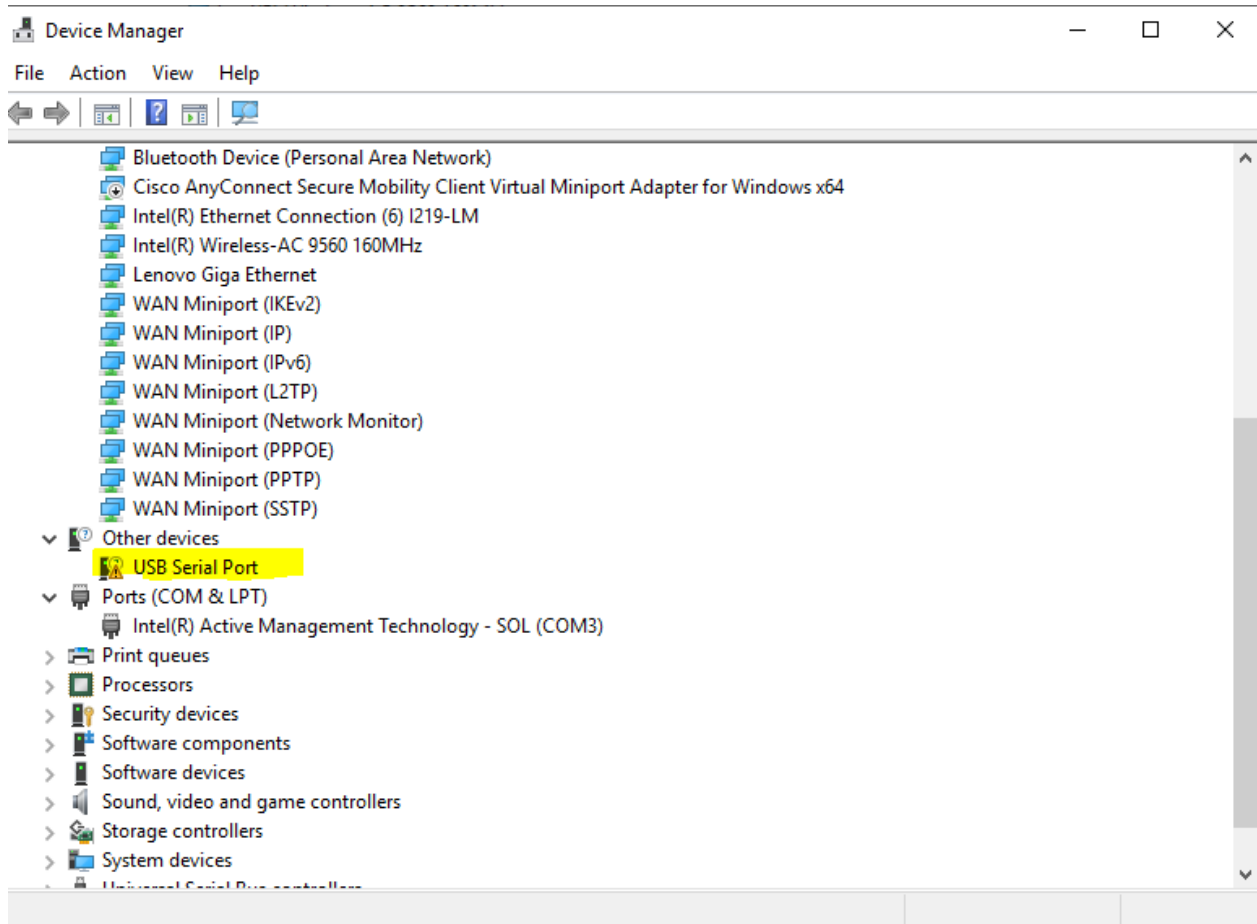
Figure 1: Device Manager - Missing USB drivers

- a) Open the “device manager” in Windows 10. And check the Ports (COM & LPT). If there is an entry like in picture 1, then the USB port is not using the correct drivers.

b) In order to solve this problem you need to install a VCP (Virtual COM Port) driver. They can be found for example [here](#). Please choose the right version for download. One of the two options in picture 2 should be the right one.
