TOTALFLOW *Technical Bulletin* 92

Fairchild Actuator Hardware Modification

Version 1.0, Revision AC (5 February, 2004)

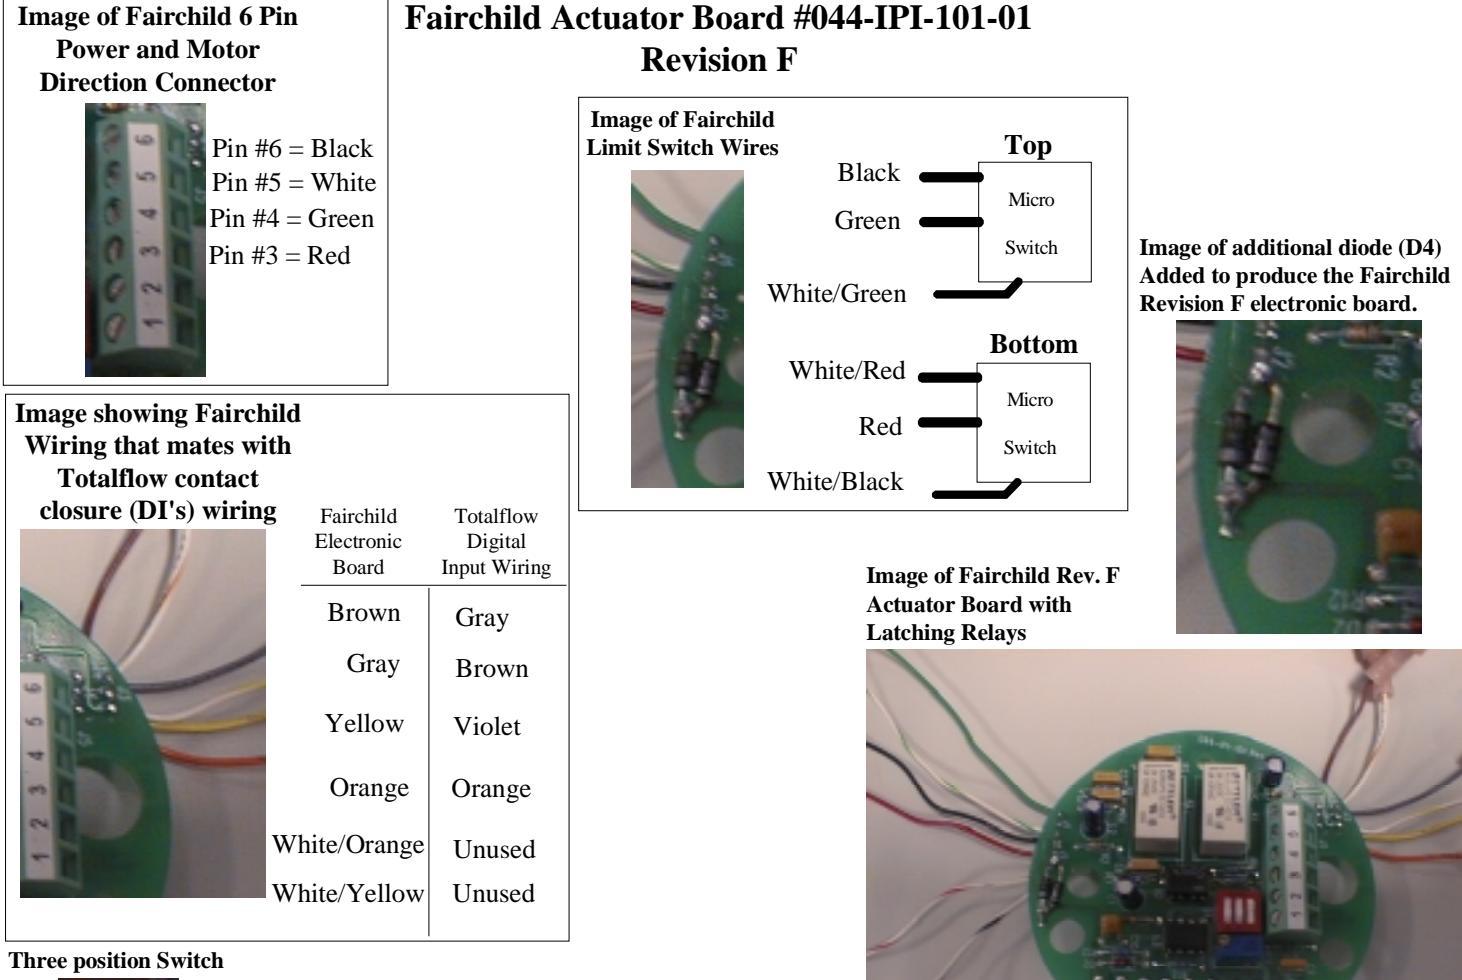
NOTE: Care should be taken when removing and re-installing the Fairchild electronic board. The board is attached using a 9 pin phoenix type connector, standoff, and 10 wires with quick connects. Use the diagram below when installing the electronic board.

Switch #1 = Closed Switch #2 = Open Switch #3 = Open
