Engineering Report 2007 - 03

5 HK Closing Spring Support

192348K01
(Arrow Head Assembly)

June 18, 2007

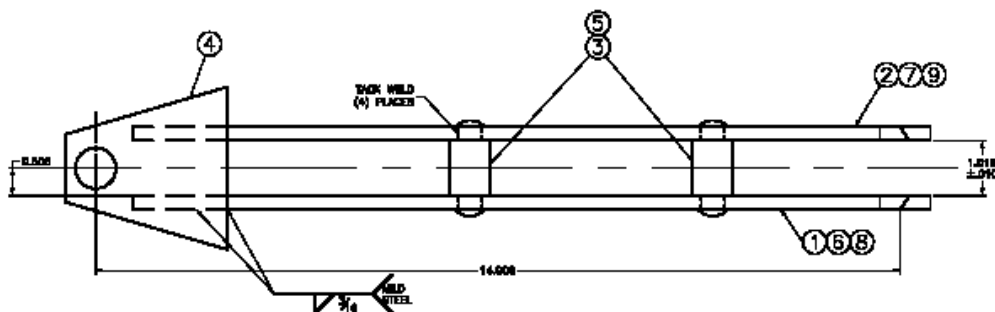
Arrow Head Assembly 192348K01

In the past it has been requested by several of ABB's customers that we evaluate the effect of broken welds on the inside of the rivets in the Arrow head assembly (items 3&5 below). There has always been some question whether the welds in the assembly contribute to the robustness of the assembly. This report is written to inform our customers of the findings of our investigation.

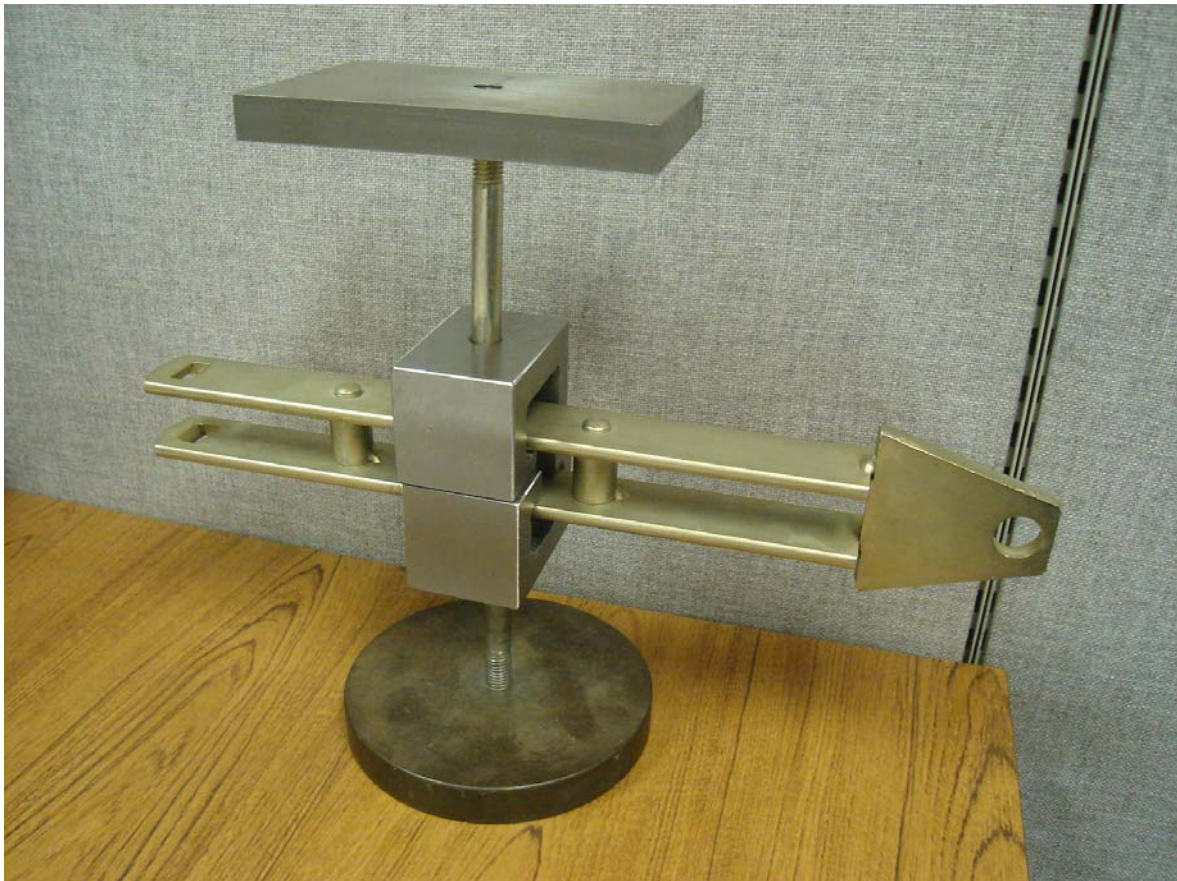
A test fixture was manufactured to apply even and consistent pressure to the Arrow Head Assembly. (Shown with an Arrow Head Assembly in place).

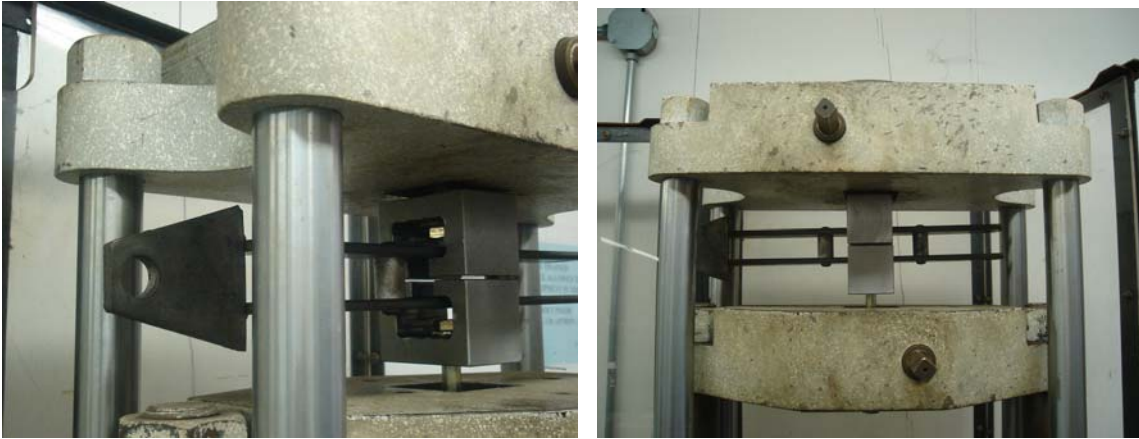
The fixture was installed in the Tenius Olsen Testing equipment. Pressure was applied to the assemblies.

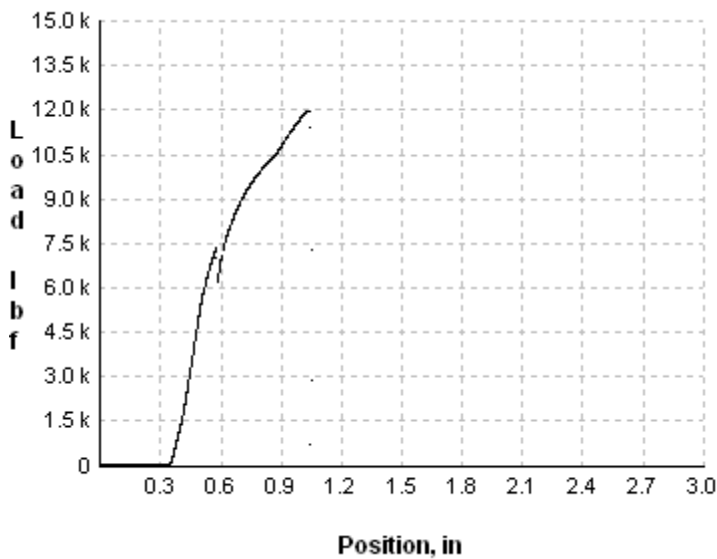
Test on Specimen T1

This test demonstrates one such failure since we started with 1 weld broken to simulate the cracked welds that our customers find during the refurbishment of breakers.

The weld reached its failure point at 7380 lbf.

The ultimate yield strength of the assembly was reached at 11980 lbf.

On the 2 assemblies that had been welded you can see a sudden drop on the graph. This signifies the point on T1 and T3 at which the welds reach their failure point.

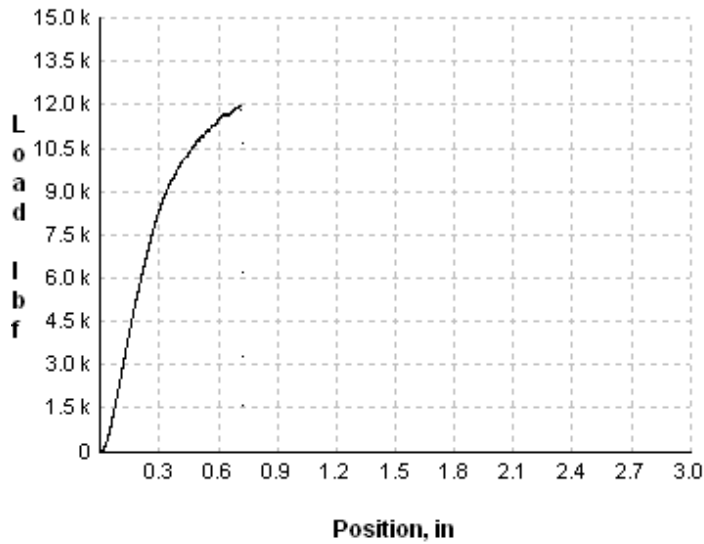
Test on Specimen T2 has no welds to demonstrate the performance of the assembly when it is found with both welds cracked.

There was no weld on T2 so you see the normal stress strain profile that begins to reach the yield strength at approximately 8000 lbf.

The ultimate yield strength of the assembly was reached at 11970 lbf.

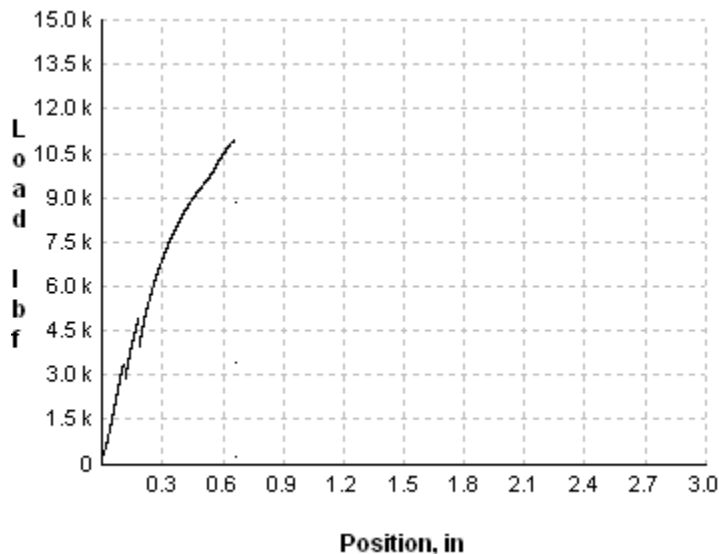
Test on Specimen T3 has 2 welds and 2 district points that show weld failures.

On Graph T3 there are 2 yield points that represent the point at which each of the wells reached their point of failure.

The first weld reached its failure point at approximately 3390 lbf.

The second weld reached its failure point at approximately 4950 lbf.

The ultimate yield strength of the assembly was reached at 10950 lbf.
