# Elastimold® solving partial vacuum effects with a vented bushing insert

Solving partial vacuum effects with a vented bushing insert

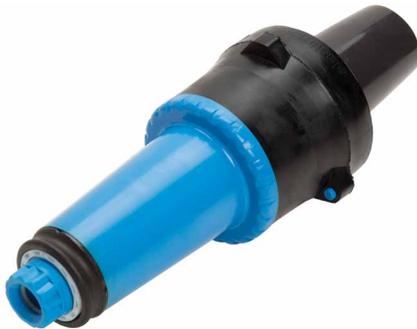
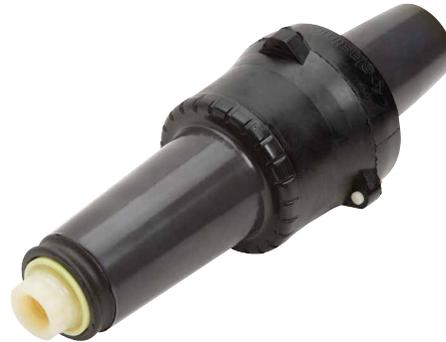
- Vents in the bushing insert ring help equalize the pressure as the connector is removed and prevent (25 and 35kV Classes) flashover conditions
- Elastimold exclusive patented design is a universal solution for any 200A connector application

Vented bushing ring allows external air to enter, which equalizes pressure and prevents conditions that lead to flashover.

**PBT interface shield**

- Excellent dielectric mating surface for secure connections
- Rubber-to-rubber sticking eliminated
- Color-enhanced visibility for easy identification and proper installation verification
- Vented ring designed to prevent partial arc flash for enhanced safety
