The power of collaboration

Service solutions across the product life cycle

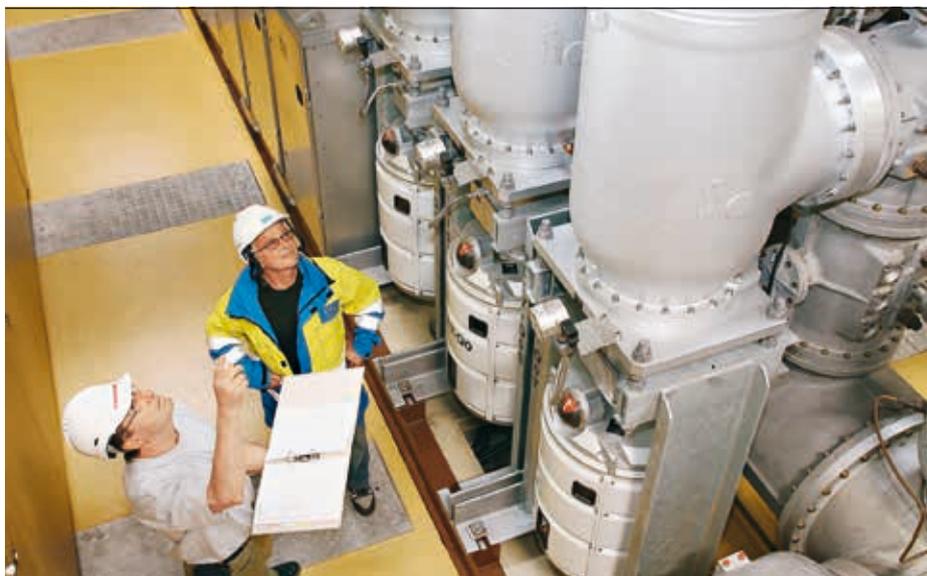
1 La Foretaille GIS substation in Switzerland. The older-generation circuit breaker type SN was replaced by an ELK SP2-1 with AHMA drive.

ABB has supplied several clients with replacement breakers for their gas-insulated switchgear (GIS) instead of revision solutions. Invariably, the replacement breaker was of a newer type and the flange distance and other parameters had to be matched. For example, in the Netherlands (Rijswijk substation) and in Switzerland (Katz substation) first-generation GIS ECKS breakers were successfully replaced with ELK SP 2-1 breakers and AHMA drives. The motivation for the replacement was dwindling repair expertise and the increasing difficulty experienced in sourcing spare parts. In the La Foretaille substation in Switzerland, a similar replacement was undertaken (in this instance an ELK SN breaker type was replaced by ELK SP 2-1), the motivation here being impending high overhaul costs → 1.

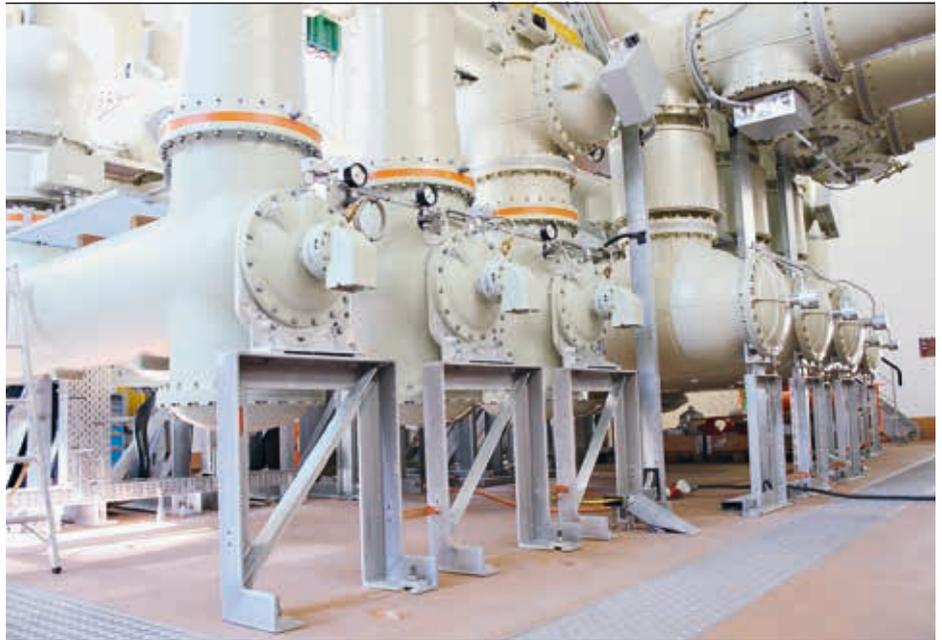
The motivation for the replacement was dwindling repair expertise and the increasing difficulty experienced in sourcing spare parts.

One good example of this centers on the delivery of two 132 kV gas-insulated ELK-04 switchbays to the 30-year-old Al Bakir trans-

former substation in Iraq. This investment became imperative in light of the growing power demand caused by the construction of a steel factory nearby and to be able to adequately interface to the Iraqi grid. The main deciding factor for the customer was that the ELK-04 design could be adapted to fit into the restricted space available. The customer received competent consulting support during the engineering stage and now has a reliable 132 kV substation, security of energy supply and guaranteed personnel safety. The previous infrastructure was kept and further extension is now simplified thanks to the use of standardized adapters.

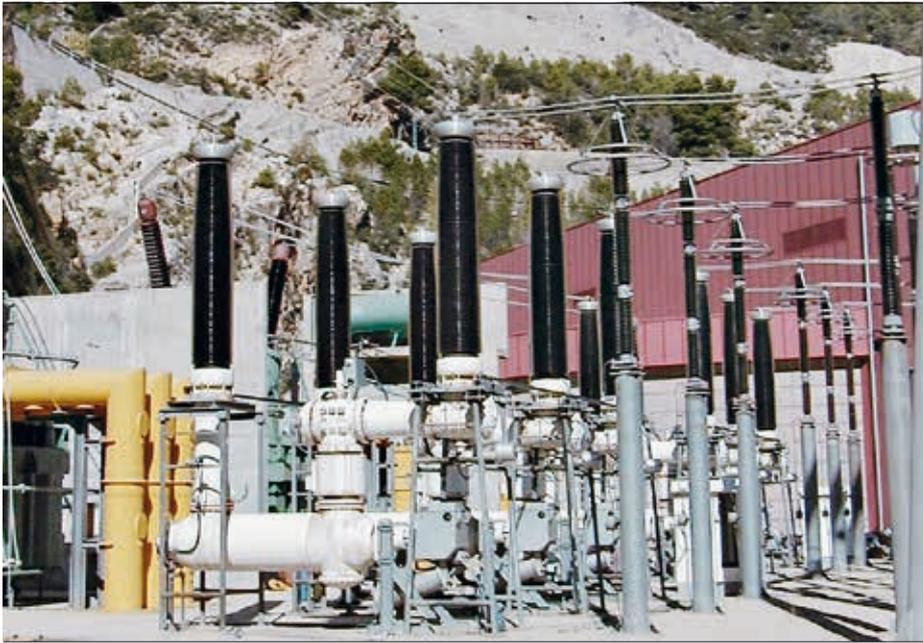
3 La Muela GIS substation, Spain. The HKA8 drive was replaced with the HMB8 on SL3-2 circuit breaker.

An alternative to changing the complete circuit breaker and drive is to change only the drive itself. In Spain, at the La Muela pumped storage substation, a retrofit drive solution was developed to replace the old HKA 8 drive on a SL 3-2 breaker → 3. The HKA drive was dismantled from the breaker pole and a new HMB 8 drive was fitted, with necessary adjustments (damping). The homologation tests were conducted on-site. Satisfied with this solution, the client, Iberdrola, decided to implement the same retrofit drive solution in the remaining bays at the same substation. In the Seinäjoki and the Tammisto substations in Finland similar drive replacements were undertaken.
