# INFLUENCE OF STRAY FLUX ON PROTECTION SYSTEMS

Z. Gajic\*, S. Holst\*, D. Bonmann<sup>□</sup>, D.A.W. Baars<sup>◊</sup>

\*ABB AB-SA Products, Sweden; <sup>□</sup>ABB AG-Transformatoren, Germany; <sup>◊</sup>ELEQ bv, Netherlands  
[zoran.gajic@se.abb.com](mailto:zoran.gajic@se.abb.com)

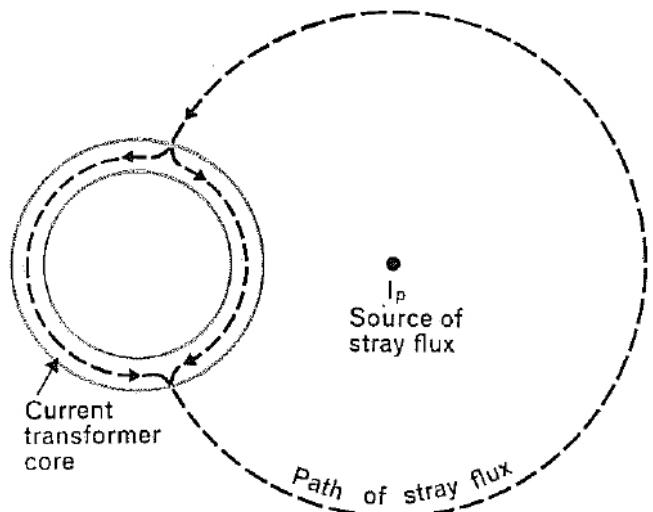
Figure 1: Stray flux influence on a CT core [9].

As shown in Figure 1, the stray flux will split in two parallel paths inside the CT core. Thus, at one side of the CT core the resultant flux will be equal to the vector sum of the “usual flux” caused by the CT primary current and the stray flux, while at the other side of the CT core the resultant flux will be equal to the vector difference between the usual flux and the stray flux. Obviously the resultant flux will have different values in different parts of the CT core and a partial CT saturation may occur.

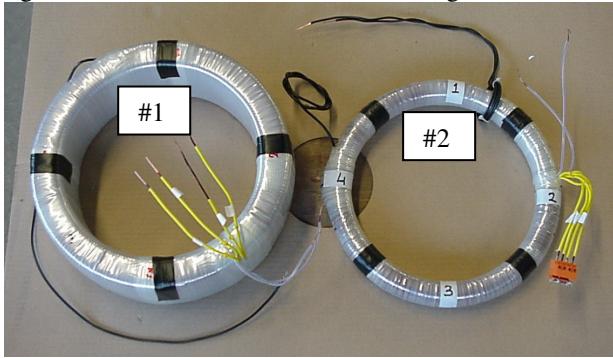
Figure 2: Tested CT cores [3].

Both CT cores have the ratio 800/1A with a relative small core cross section. The only important difference between the two CT cores is the core cross section area. The core cross section area of the CT #1 is  $17.1\text{cm}^2$  and the core cross section area of the CT #2 is  $1.9\text{cm}^2$ . On each CT an additional secondary flux equalizing winding is wound. This winding is divided in four equal sections, evenly distributed around the core circumference (see black markings on the two CTs in Figure 2). The influence of the flux equalizing winding will be explained later in the paper. Note that its influence can be enabled or disabled by changing externally available connections of the four segments ends. The stray flux influence is tested by positioning the CT core close to an adjacent primary conductor, as shown in Figure 3.

When the laboratory testing of CT #2 (see Figure 2) was repeated with the flux compensation winding enabled by connecting its four segments in accordance with the second solution shown in Figure 13b, no secondary current spikes were observed when current was injected through the primary conductor adjacent to the CT core (see Figure 3). In practice, the flux equalizing winding is often combined with the main CT secondary winding as shown in references [8, 9].

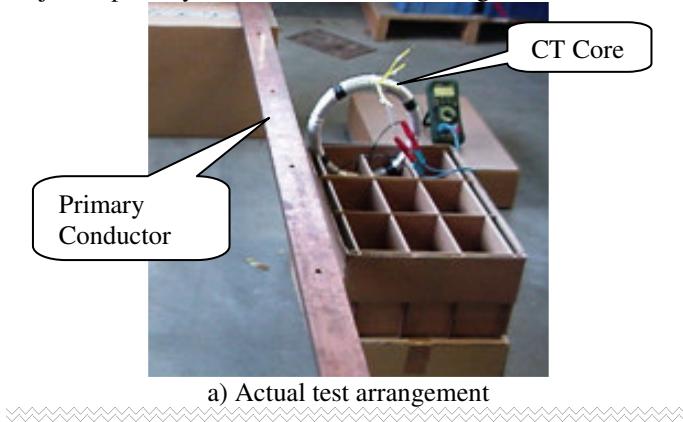
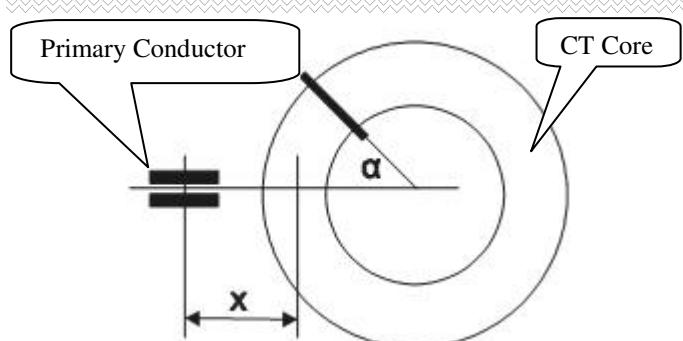
a) Actual test arrangement

b) Principle drawing  
Figure 3: Laboratory test setup [3].

Figure 3a was taken during laboratory testing, while Figure 3b represents the simplified geometrical view of the test setup. The distance X is 6cm during these tests. The test was done by applying the 50Hz, AC current with the RMS value of 6.5kA. The primary current could be injected with or without a DC offset. The applied current through the primary conductor and the CT secondary current were recorded by an oscilloscope as Channel 1 and Channel 2 respectively. These two waveforms are given in Figure 4 [3]. In the Figure 4a the two waveforms are given when the DC offset is present in the primary current. The CT secondary current with maximum peak of 1.5A was recorded during this test. In Figure 4b the two waveforms are given for the symmetrical primary current with AC RMS magnitude of 6.5kA. The recorded peak of the CT secondary current during this test reaches 0.2A. Note that secondary current spikes are only observed during testing of CT #2 and not during testing of CT #1.

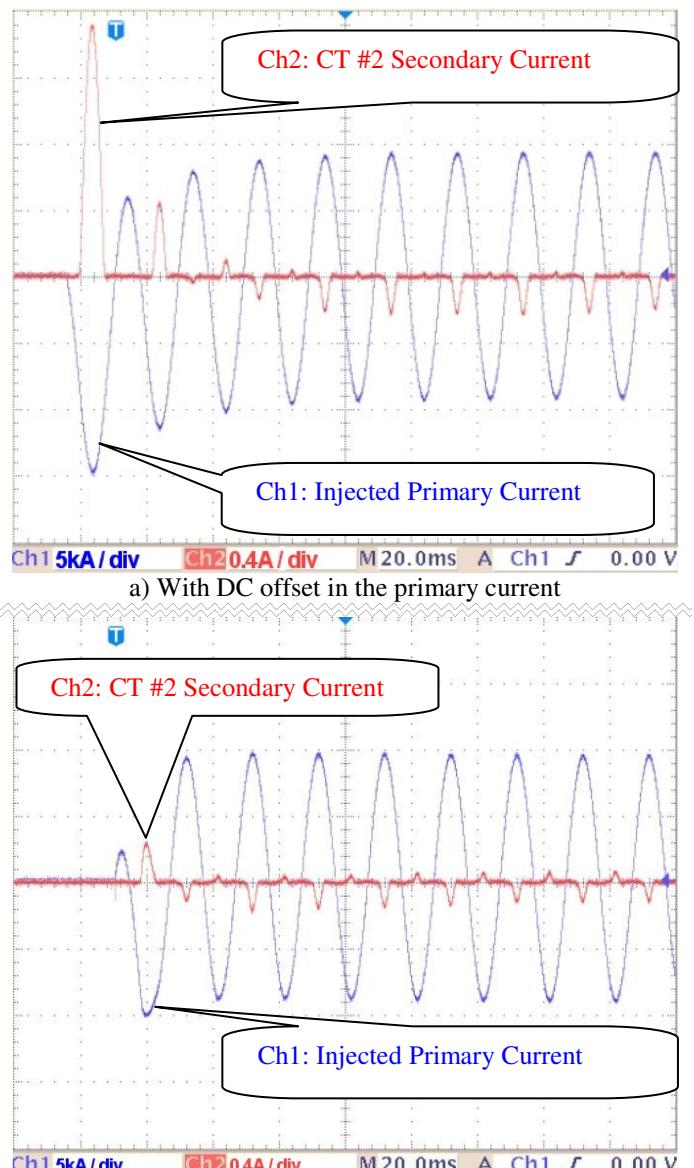
b) Without DC offset in the primary current  
Figure 4: Captured waveforms for CT #2 in the laboratory with disabled influence of the flux equalizing winding [3].

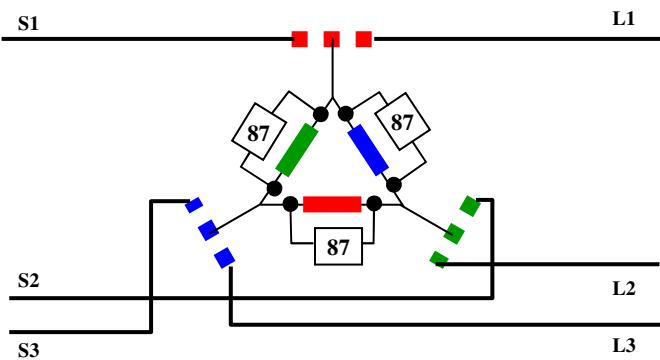
Within a symmetrical, single-core PST [6] with rating data 450MVA, 138/138kV,  $\pm 58^\circ$ , 60Hz, six buried CTs, with ratio 3000/5 and class C800, are installed. Note that two CTs, one at each side of every phase of the delta winding are used for the differential protection scheme, as shown in Figure 5.

Figure 5: Principle drawing for symmetrical, single-core PST.

Unwanted operation of the differential protection, applied in accordance with Figure 5, has occurred during the PST energizing. The current waveforms, captured by the built-in disturbance recorder within this differential relay, are shown in Figure 7.

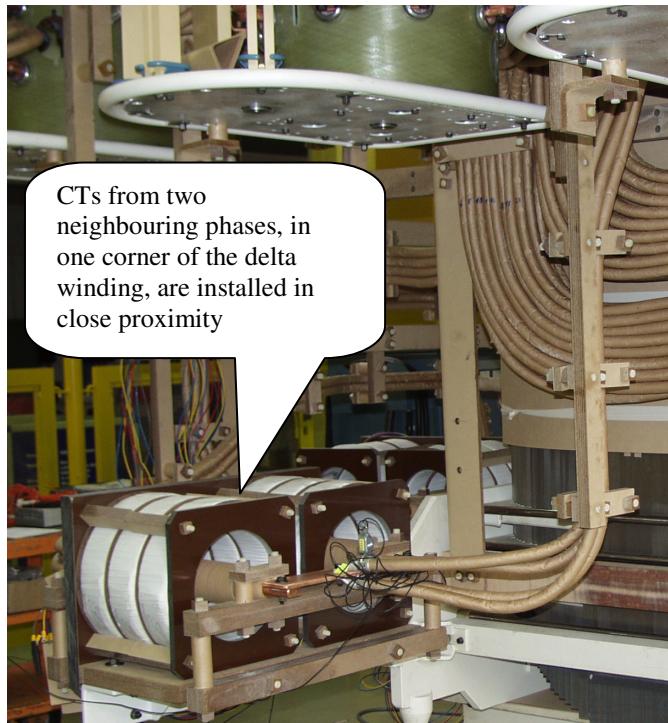
Due to space limitations inside the tank two CTs located in one “corner of the delta winding” are installed under the on-load tap-changer and next to each other, as shown in Figure 6.

Figure 6: Two buried CTs installed next to each other.

The two recorded currents should have the same waveforms with opposite polarity (e.g. their sum shall be zero). However, it is clear that one of the two currents is distorted for a part of the power system cycle. Actually, its peak value is almost completely reversed. Later it was concluded that this waveform distortion was caused by stray flux from the primary current in the neighbouring phase (see Figure 6).

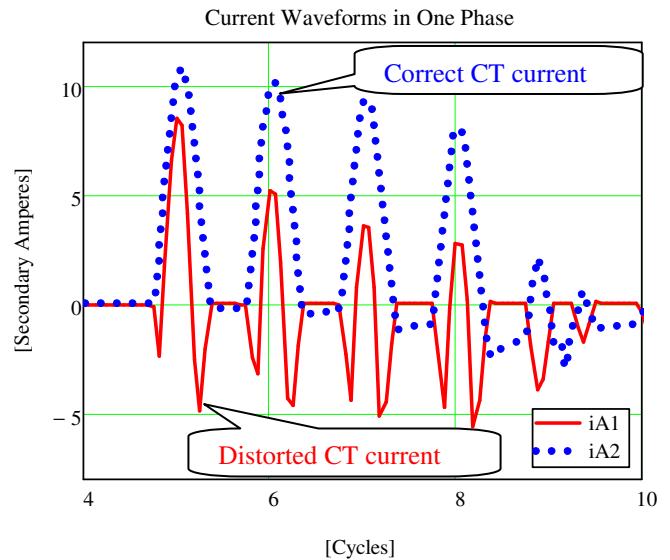
Figure 7: Recorded currents at two ends of phase L1 of the delta winding.

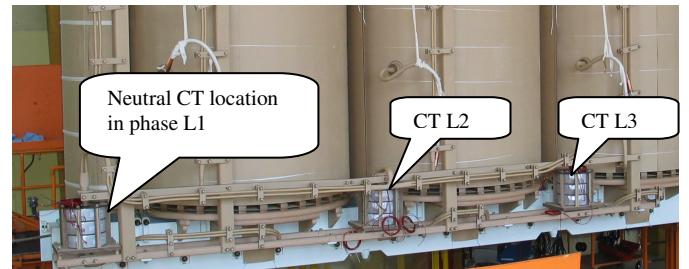
Within a symmetrical, dual-core PST [6] with rating data 600MVA, 232/232kV,  $\pm 35^\circ$ , 50Hz, buried CTs (with rated data 1200/1A; 10P20; 60VA) are installed. CTs are located at the neutral point of the PST primary exciter winding in each phase, in accordance with protection scheme recommendation in [5]. Due to space limitations, these CTs are located next to the yoke of the magnetic core of the excitation transformer (see Figure 8). Unwanted operation of the main differential protection, applied in accordance with Figure 9 and reference [5], has spuriously occurred during PST energizing.

Figure 8: CTs installed in the individual phases of the exciter winding neutral point.

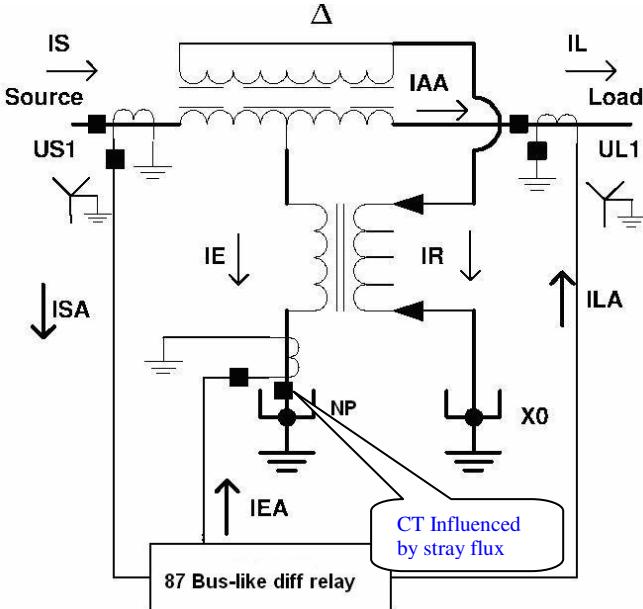
Figure 9: PST main differential protection scheme.

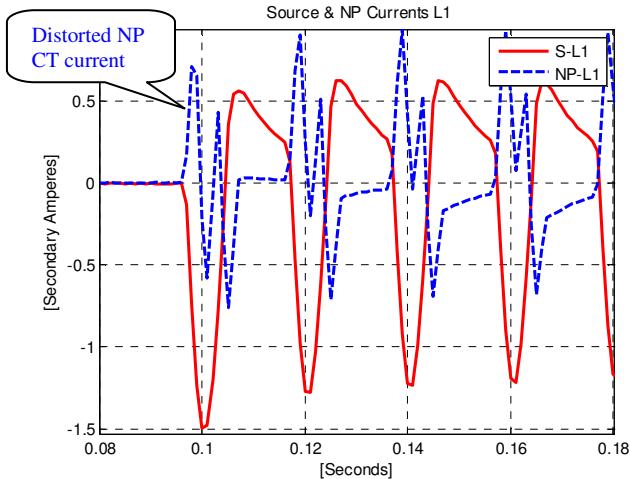
The current waveforms in phase L1, captured by the built-in disturbance recorder within this differential relay, during one PST inrush case, are shown in Figure 10.

Figure 10: Phase L1 Source- and NP-side currents for one PST inrush case.

Because the Load-side circuit breaker was open during PST energizing, the two recorded currents should have the same waveforms with opposite polarity (e.g. their sum shall be zero). However, it is clear that the neutral point current is distorted for a part of the power system cycle. Actually, its peak value is reversed. Later it was concluded that this waveform distortion was caused by stray flux from the PST excitation transformer excitation winding (see Figure 12a).

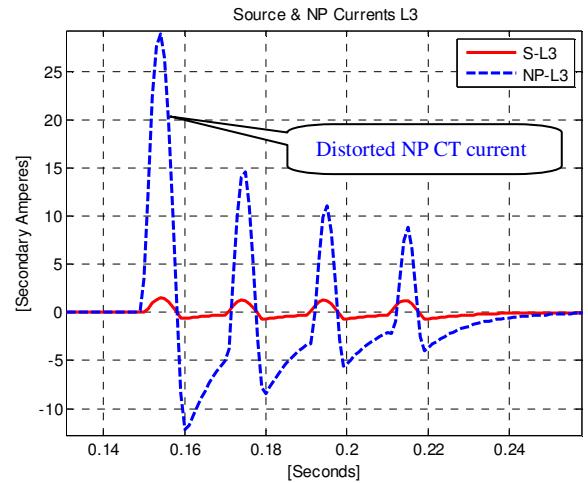
Several unwanted operations of the differential relay were recorded. During an another inrush cases the distorted CT current reached more than 25A secondary in peak current value in phase L3, as shown in Figure 11. Such big current caused unwanted operation even of the unrestrained differential protection element.

Figure 11: Phase L3 Source- and NP-side currents during another PST inrush case.

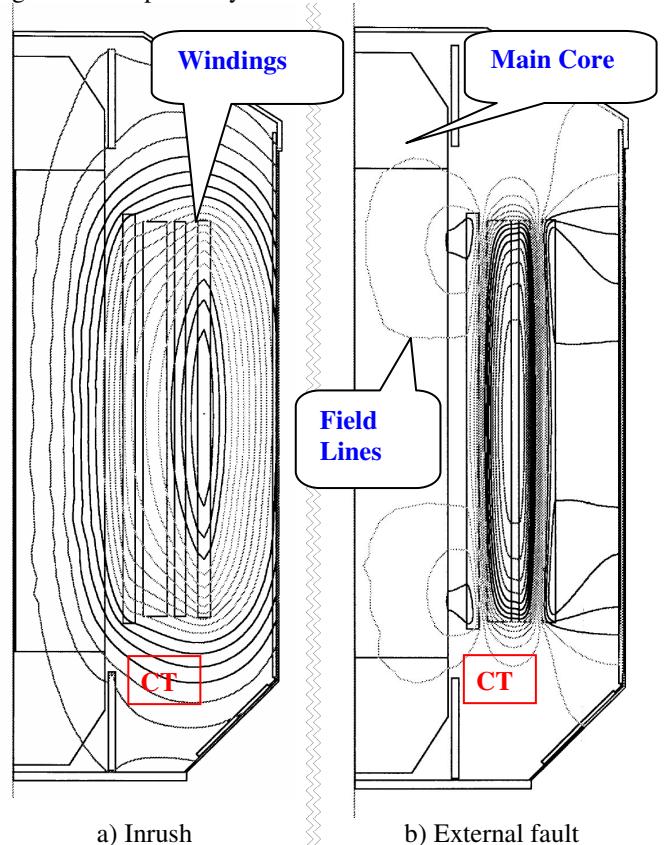
Finite element magnetic field calculations were performed for this PST in order to check the stray magnetic field during inrush and during external fault, as shown in Figure 12a and Figure 12b respectively.

a) Inrush      b) External fault

Figure 12: Stray magnetic field within the PST.

During external faults there is ampere-turn balance between excitation transformer primary and secondary windings and the stray flux is essentially contained in the main ducts between the two windings. During inrush the secondary winding is open circuited and the magnetic field caused by the inrush current spreads out in the entire transformer tank.

From Figure 12, it can be concluded that much bigger stray flux is present at the CT location during inrush condition than during an external fault. Such theoretical calculations were confirmed by primary full scale testing. Different types of external faults were applied on the PST Load-side and stability of the differential protection was verified.

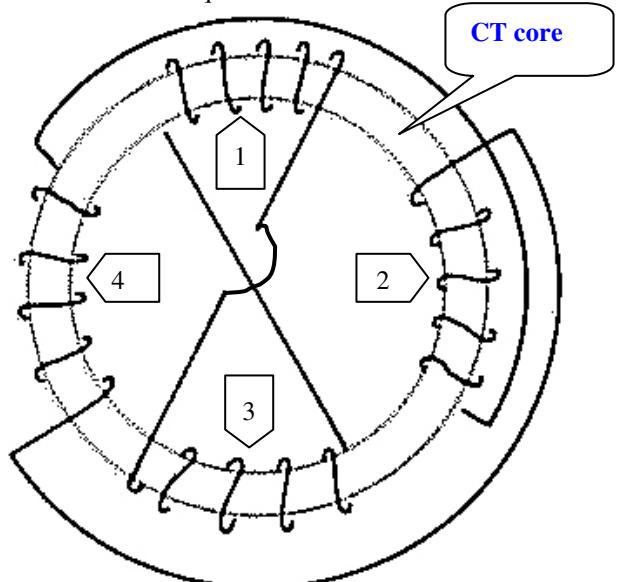
a) First solution [9]

Figure 13: Possible connections of flux equalizing winding.

In the first solution, by cross-connecting the two segments located on diametrically opposite parts of the CT core (i.e. 1&3 and 2&4 in Figure 13a), a path for flow of a circulating current between each pair of the flux equalizing winding segments, during stray flux condition, is achieved. These circulating currents will produce a magnetic field in the CT core with an opposite direction to the stray flux diminishing its influence on the CT. Note that these circulating currents will not exist during normal operation of the CT when the stray flux is not present.

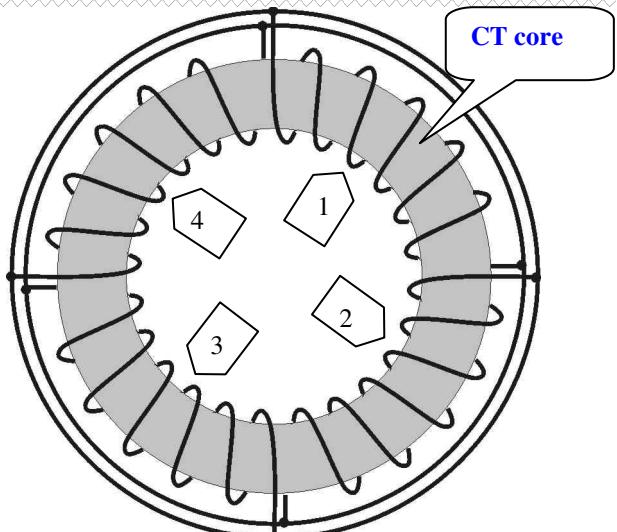
b) Second solution [3,7]

In the second solution, shown in Figure 13b, all segments are connected in parallel. This connection enables path for flow of circulating currents between all segments of the flux equalizing winding, during stray flux condition. These circulating currents will produce a magnetic field in the CT core with an opposite direction to the stray flux diminishing its influence on the CT.
