Cylmate® Systems

– award winner

Reprint from **The Scandinavian Shipping Gazette**, Yearbook of Maritime Technology 2005

Cylmate Systems – award winner

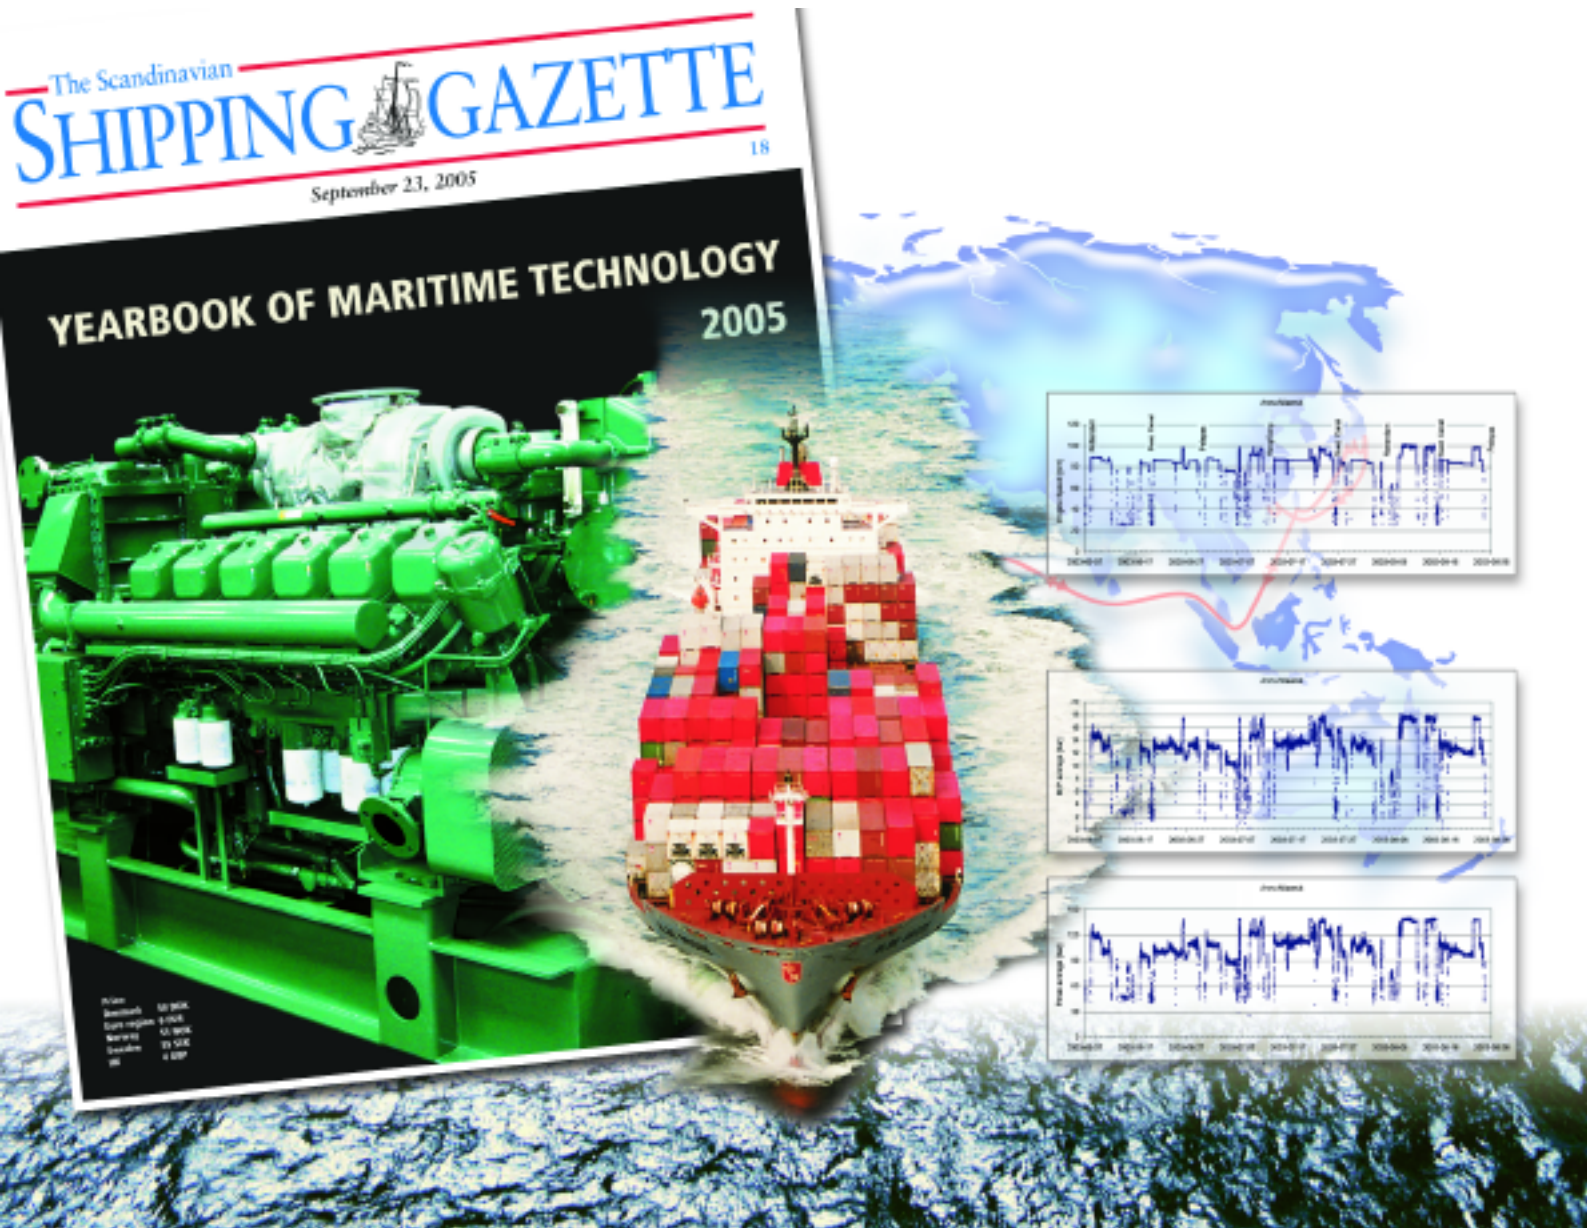
Cylmate pressure transducers makes it possible to constantly measure the combustion pressure in large two-stroke engines.

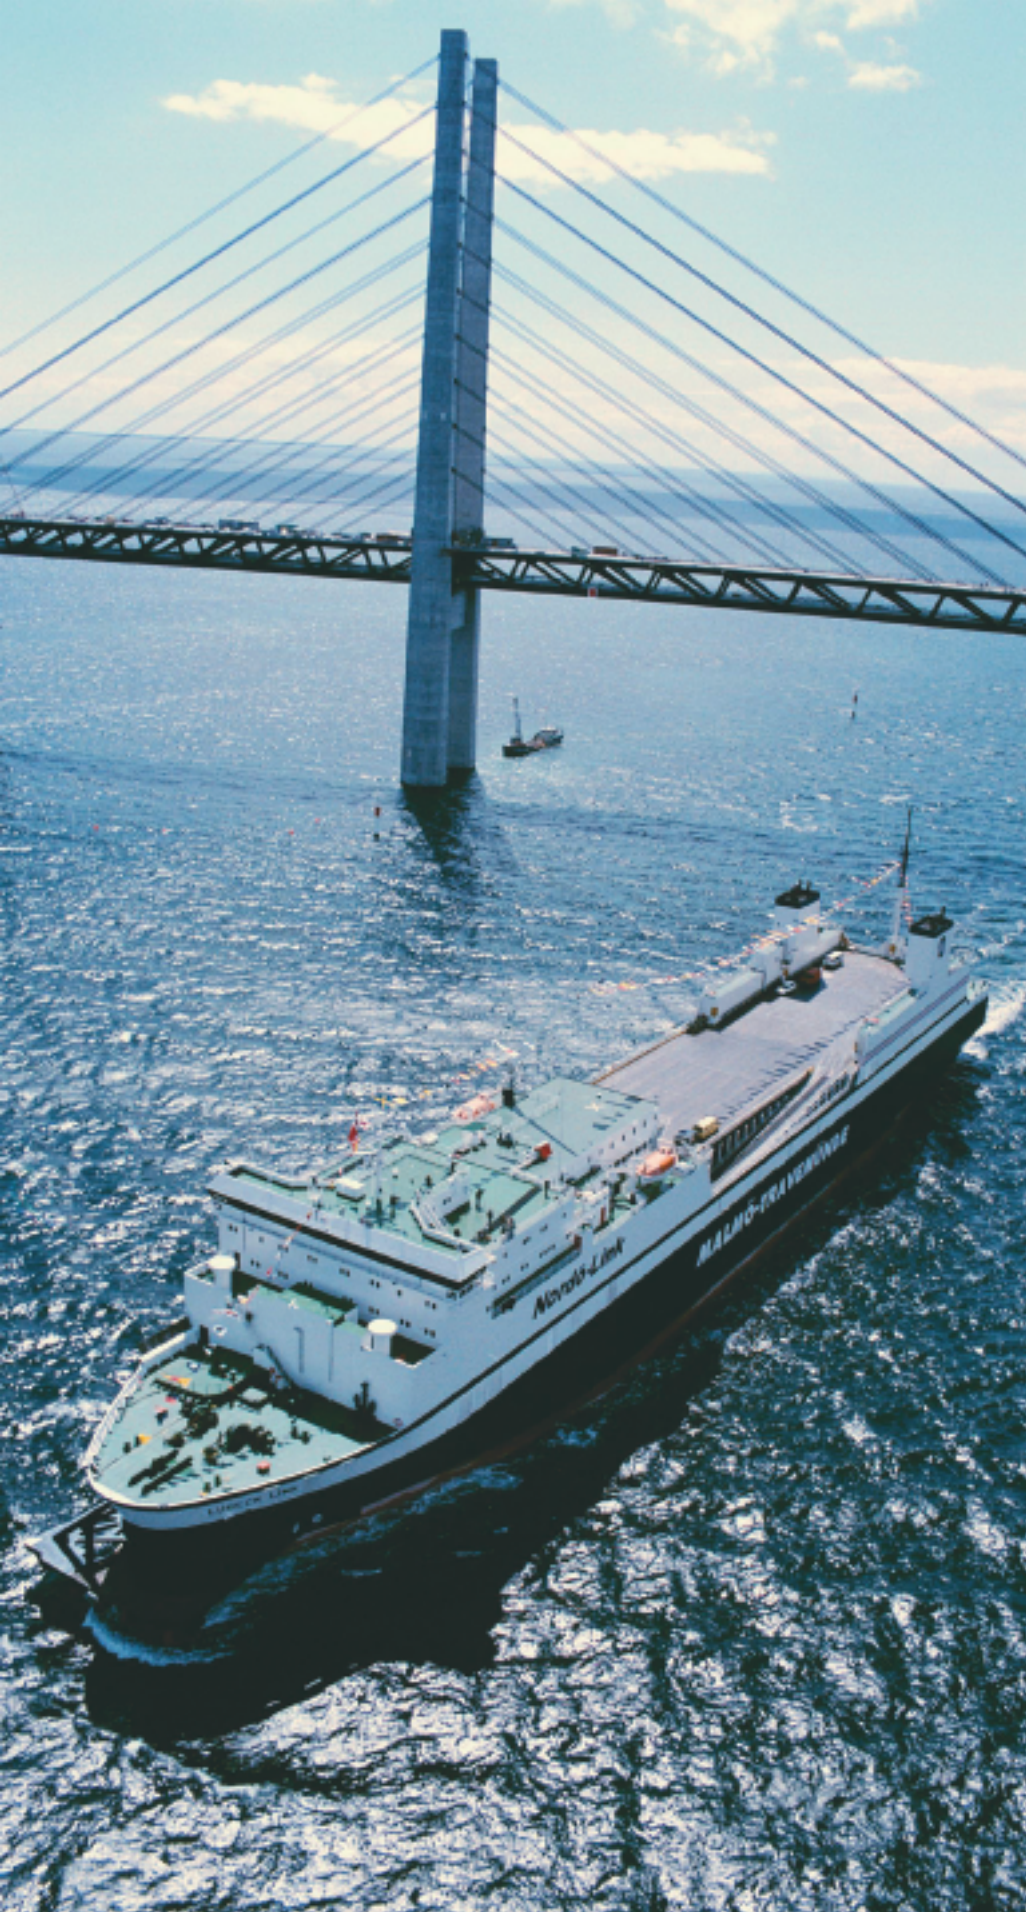
“Malmö Link”

M/V Malmö Link is a ro-pax ferry with two Sulzer 6RND68M engines. On the port engine of this vessel, the first Cylmate system was installed early in year 2001. One year later, the starboard engine was also equipped with Cylmate.

Malmö Link identified a problem with cylinder 5 on starboard engine. For all loads, except full load, the pressure was significantly lower than on the other cylinders. Initially, the crew changed the fuel valve, but the problem came back after seven to eight hours.
