## Case Study PCS80 Active Voltage Conditioner

### ABB voltage conditioner helps the mail go through

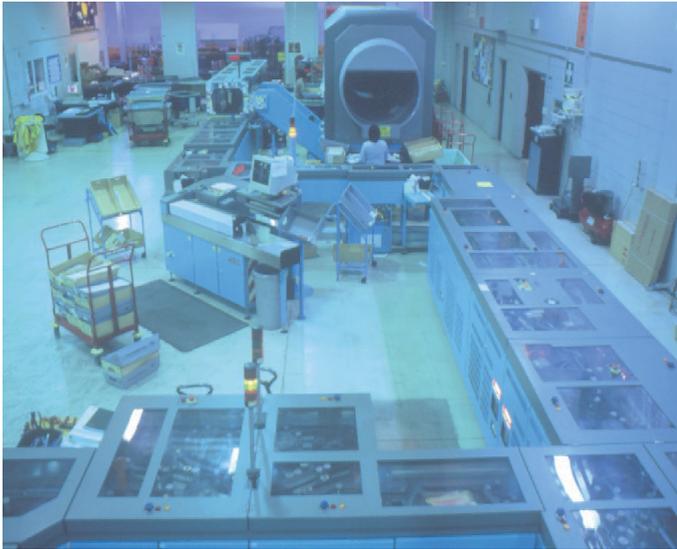
NSMC Mail Sorting Machine

At 33 metres long, the mail sorting machine occupies a very large floor space. Letter mail is deposited into a large rotating section at one end, inevitably dubbed the "concrete mixer," from where it tumbles into the start of the sorting process.

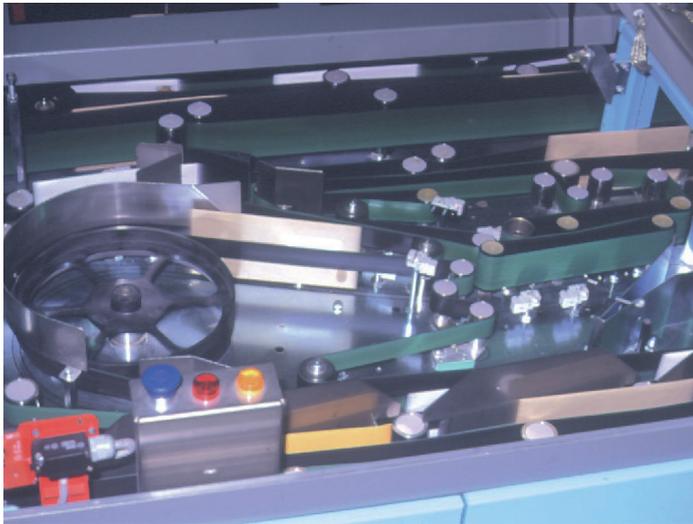
**NSMC Mail Sorting Machine**

Each mail sorting machine has two separate power supplies. The seven computers which control the entire process are critical and so have an ABB Uninterruptible Power Supply (UPS), while the mechanical machinery's essential power is conditioned by the PCS80 AVC which stands unobtrusively against the wall. A UPS would solve all brownout and power cut problems, but at considerably more capital cost plus maintenance and regular replacement of batteries.
