ABB OVR-3 Recloser Passes Severe Environment Testing

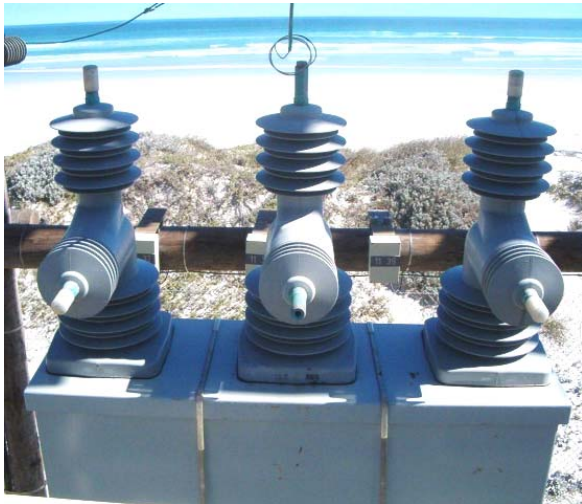
OVR-3 at KIPTS

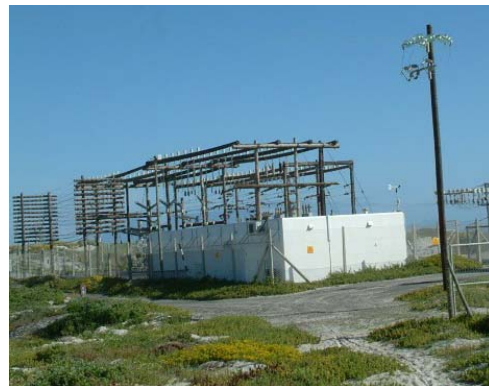
KIPTS test site

One such test site is the Koeberg Insulator Pollution Test Station (KIPTS), which is run by the ESKOM Electric Utility. KIPTS is located 17 miles (27 km) north of Cape Town, South Africa and is characterized as having:

- Dry summers
- High winds
- High exposure to UV radiation
- Seasonal rainfall
- Extremely heavy levels of marine & industrial pollution (salt, etc.)

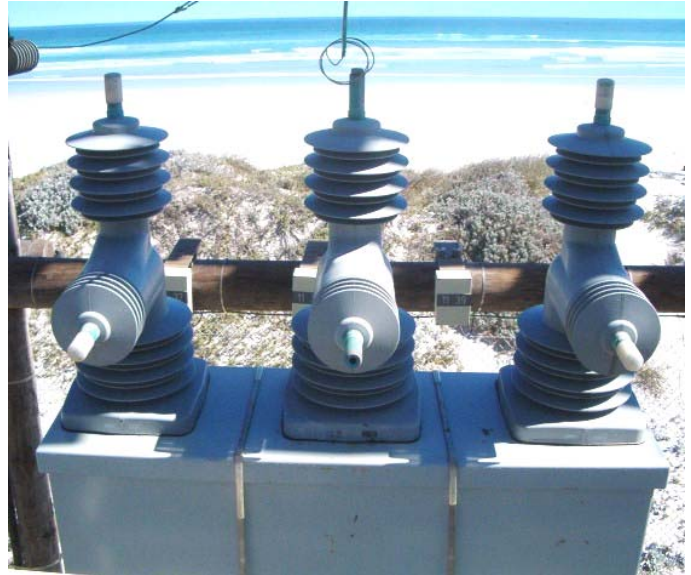
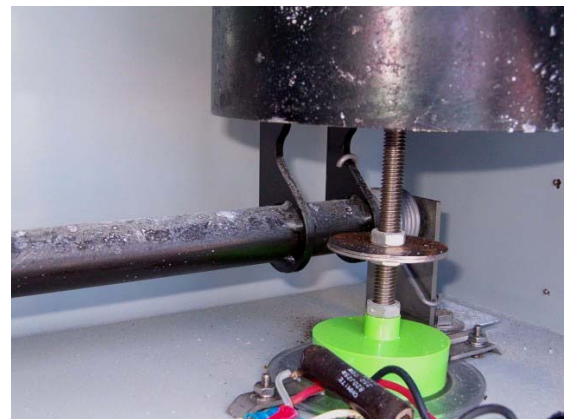
No damage to magnetic actuator assembly

- **PASSED** - Testing for use in marine and industrial environments
- **PASSED** - No signs of material erosion, tracking, cracks, or punctures reported
- **PASSED** - No more than one instance of insulation leakage current exceeding 750 mA (only three instances allowed)
- **PASSED** – Heavy-to-very heavy pollution test
- ✓ **APPROVED** - For marine & industrial environments
- ✓ **APPROVED** – For inland non-coastal environments
- ✓ **Stainless steel high voltage cabinet and internal components did not corrode even with heater off during entire test**
