Retrofit for 20 years old reactor in the Oskarshamn 1 nuclear power plant

For the first time in the history of nuclear energy, workers have carried out repairs on the bottom head of a reactor pressure vessel which has been in operation for more than 20 years. Working within the framework of the OKG FENIX project, the goal of which is to extend the power generation capability of the existing plant, ABB Atom carried out extensive inspections and repair work inside the pressure vessel of the Oskarshamn 1 nuclear power plant. The retrofitted components now comply with the Swedish nuclear inspectorate's conditions for renewal of the plant's operating licence. It is planned to further modernize the power plant in a second project phase that will last until the year 2000.

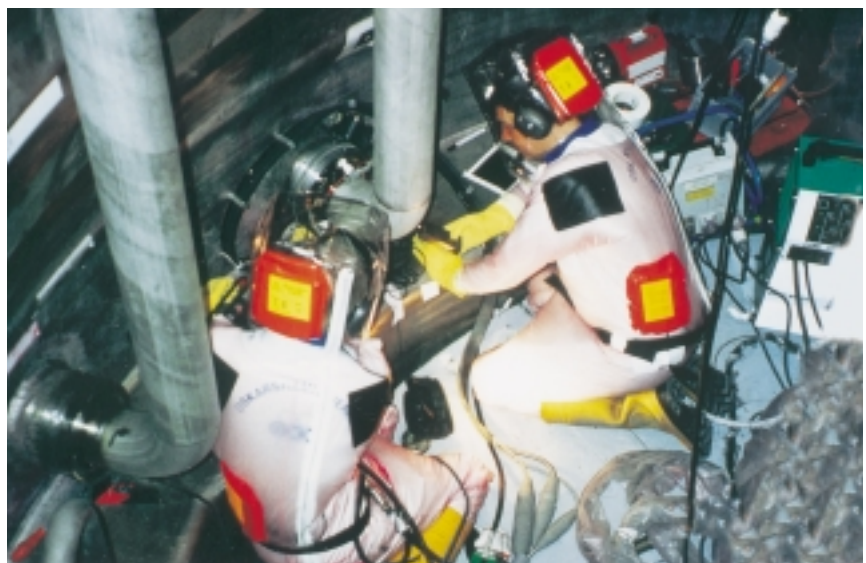
Welding feedwater pipes in the reactor pressure vessel **5**

The order called for, among other things, the replacement of six feedwater risers, including the penetrations, inside the pressure vessel **5**, the penetrations for the core spray system and all the piping used for level measurement. Other work included repairs to the housing for the neutron detector and replacement of the core shroud support. Finally, the reactor pressure vessel and the core internals had to be made ready for operation again.

To reduce the number of weld seams to be tested, ABB Atom introduced design improvements at various locations. For example, the pressure vessel wall penetrations for the feedwater tubes, which had been welded in the past, were replaced by forged parts.
