WHITE PAPER

# Solving partial vacuum effects with a vented bushing insert

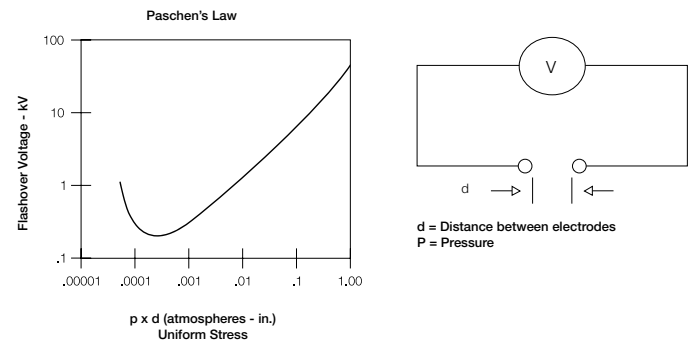
Paschen's Law explains the effect of decreased pressure on the dielectric strength of air, and is illustrated with the following curve:

To see the effect of pressure, let  $d = 1$  inch. The horizontal axis then represents pressure only. Note that at 1.0 atmosphere, the flashover voltage for 1 inch is approximately 60kV, and at 0.1 atmosphere, the flashover voltage decreases to approximately 8kV.

This curve illustrates the general relationship and does not represent true data. An accurate curve can be developed for small gaps under controlled pressure, temperature and humidity conditions. The principle applies to the complicated geometry of a connector.

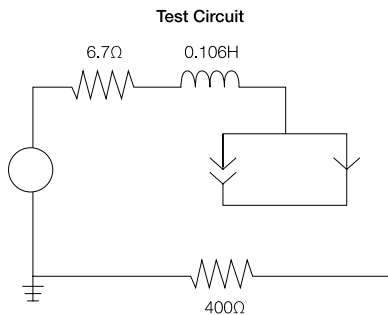
#### 1. Circuit

Since voltage, and not current, is the critical parameter, a zero-current test circuit was set up.

The applied voltage was selected at 27.5kV, much in excess of normal line-to-ground voltage, to increase the failure rate. This allowed evaluation of test and design parameters with a limited number of samples.

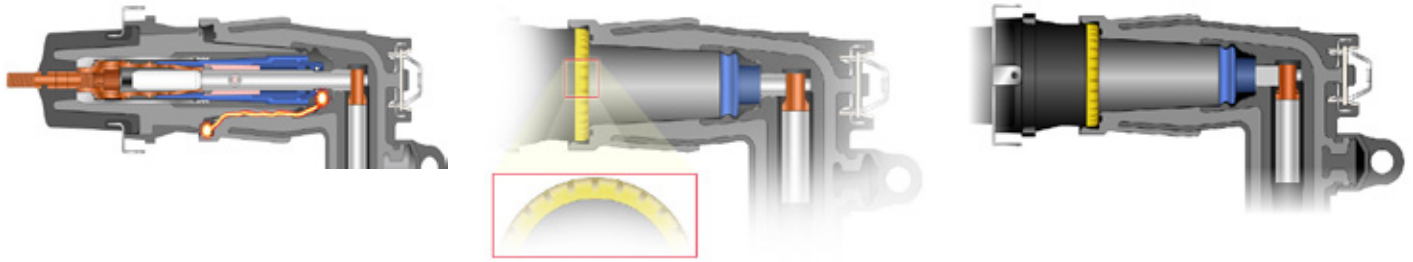
It was also shown that the insulated cap design with the internal conductive parts (probe and internal shield) removed will provide flash-free operation.

- As the connector is removed from the bushing insert, shield separation causes high electric stress
- High Stress + Partial Vacuum = Partial Discharge and Ionized Gas
- Ionized gas is conductive, providing flashover path from probe to shield

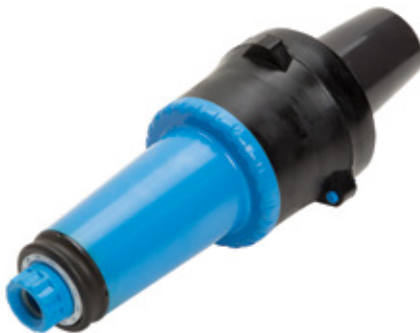
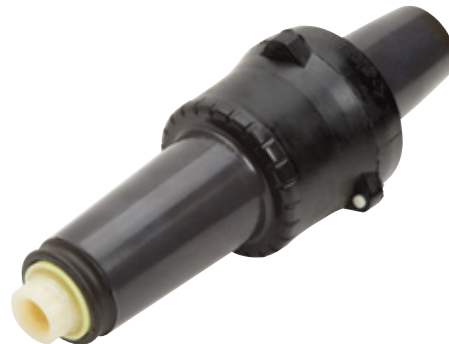
- Vents in the bushing insert ring help equalize the pressure as the connector is removed and prevent (25 and 35kV Classes) flashover conditions
- Elastimold exclusive patented design is a universal solution for any 200A connector application

Vented bushing ring allows external air to enter, which equalizes pressure and prevents conditions that lead to flashover.

- Excellent dielectric mating surface for secure connections
- Rubber-to-rubber sticking eliminated
- Color-enhanced visibility for easy identification and proper installation verification
- Vented ring designed to prevent partial arc flash for enhanced safety
