TOTALFLOW Technical Bulletin 122

μ FLO (microFLO)

Local Communications Port Issue Totalflow Technical Bulletin

Version 4.0, Revision AD (2 December 2009)

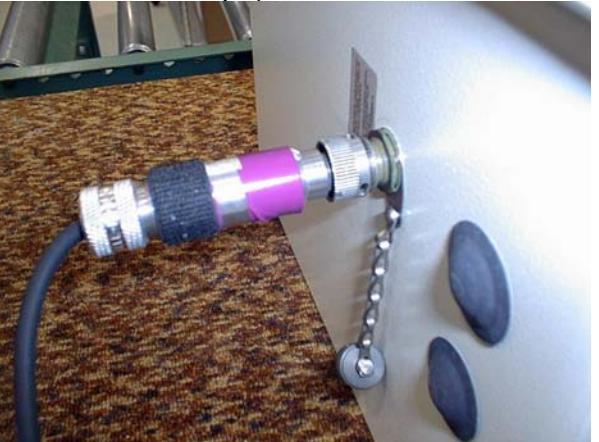
To determine if your microFLO has this problem first connect a PCCU cable to the suspect unit (this is required to activate the port and to see the voltages described in the next two steps).

Next, measure between pin 1 and 4 (green wires, pin 4 is ground) with a multimeter set to DC volts. Voltage should be approximately (-)5 vdc to (-) 15 vdc +/-10%

If either voltage measures between (-)2 and 0 vdc then you have a shorted MOV and the board needs to be repaired and upgraded to the –003 revision level.

ABB has enhanced the local serial port circuitry to make the port more resistant to damage from static electricity. Additional resistors have been added to the serial port circuitry. The addition of these resistors will be present in all electronic board with a 2100767-003 part number. The –001 and –002 boards do not have this enhancement.
