System 800xA

Release Notes

New Functions and Known Problems

System Version 5.1 Rev E

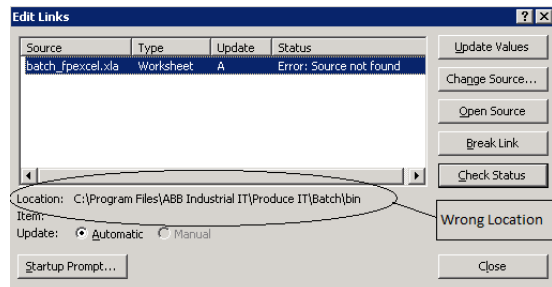
3. The location encircled in [Figure 4](#) is incorrect. The path has to be updated. Click **Change Source**.

Figure 4. Path to be Changed

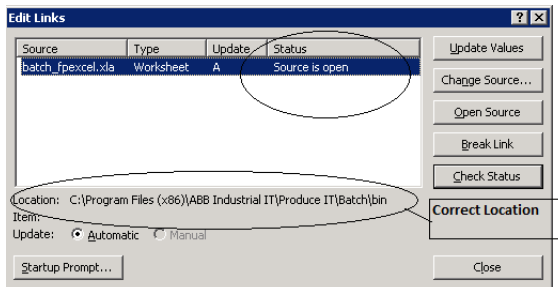
- Click **Check Status** to check the status of the file link.
Figure 5 shows the updated view of the Edit Links status displaying the **Source is open**.

Figure 5. Correct Path Selected
