Document class Release Note
 Document ID 1MRS257359
 Business Unit ABB Oy, Distribution Solutions
 Page 1/2
 Date 12.03.2021

Firmware update release 1.2.1 for SSC600 1.0 Feature Pack 2

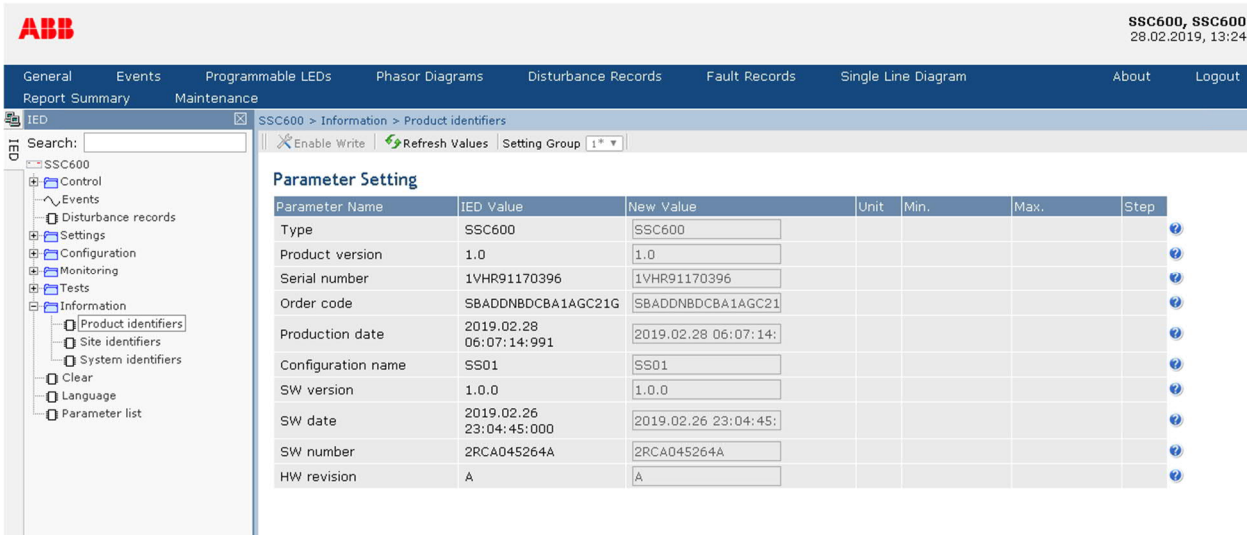
Fig. 2 Current firmware revision of the SSC600 product

The screenshot shows the ABB WHMI interface for an SSC600 device. The 'Parameter Setting' table is displayed, showing various parameters and their current values. The 'Order code' parameter is highlighted, showing the value 'SBADDNBDCBA1AGC21G'.

Parameter Name	IED Value	New Value	Unit	Min.	Max.	Step
Type	SSC600	SSC600				
Product version	1.0	1.0				
Serial number	1VHR91170396	1VHR91170396				
Order code	SBADDNBDCBA1AGC21G	SBADDNBDCBA1AGC21				
Production date	2019.02.28 06:07:14:991	2019.02.28 06:07:14:				
Configuration name	SS01	SS01				
SW version	1.0.0	1.0.0				
SW date	2019.02.26 23:04:45:000	2019.02.26 23:04:45:				
SW number	2RCA045264A	2RCA045264A				
HW revision	A	A

To identify the current firmware revision of the SSC600, please refer to Fig. 2.
