## Firmware update release 1.3.0.B1 for 630 series product version 1.3 protection relays

This firmware update release 1.3.0.B1 is for the following 630 series protection relays:

- REF630
- REM630
- RET630
- REG630

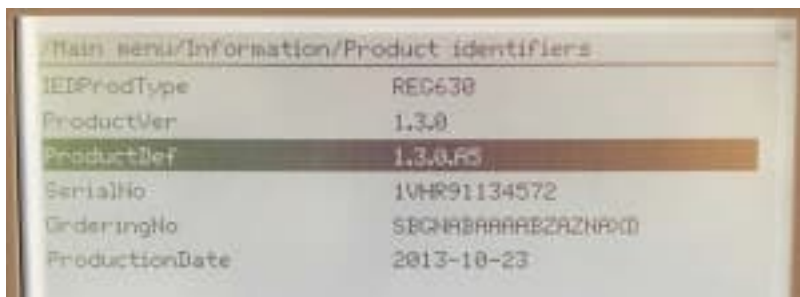
*Fig. 2 Current firmware revision of the 630 series protection relay*

To identify the current firmware revision of 630 series relays, please note the parameter **ProductDef**, refer to Figure 2.
