Document class	Release Note
Document ID	2NGA002169
Classification	Public
Business Unit	ABB Oy, Distribution Solutions
Page	1/8
Date (dd.mm.yyyy)	19.03.2024

## Firmware update release 2.0.9 for REC615 / RER615 protection and control relays

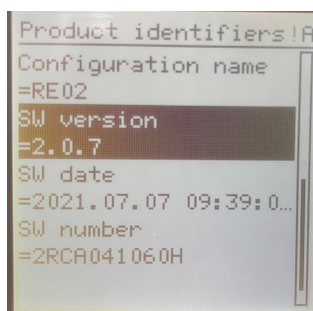
Fig. 2 The firmware revision of the REC615/RER615 control and protection relay

To identify the current firmware (SW) revision of the REC615 / RER615 protection and control relay, please Refer to Fig. 2.
