Document class Release Note
Document ID 2NGA001298
Business Unit ABB Oy, Distribution Solutions
Page 1/11
Date 03.06.2022

Firmware update release 2.1.15 for 620 series IEC product version 2.0 FP1 protection relays

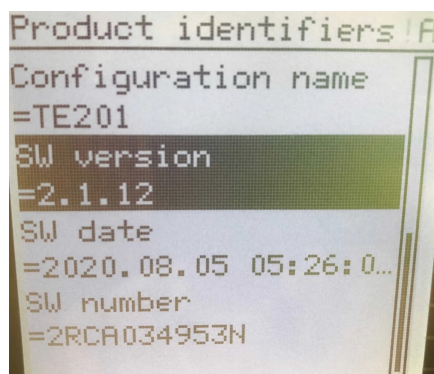
Fig. 2. Product identifiers of the 620 series protection relay

To identify the current firmware (SW) version of the 620 series protection relay, please refer to Fig. 2.
