Document class Release Note
 Document ID 1MRS759125
 Business Unit ABB Oy, Distribution Solutions
 Page 1/4
 Date 15.02.2019

Firmware update release 1.3.0.A8 for 630 series product version 1.3 protection relays

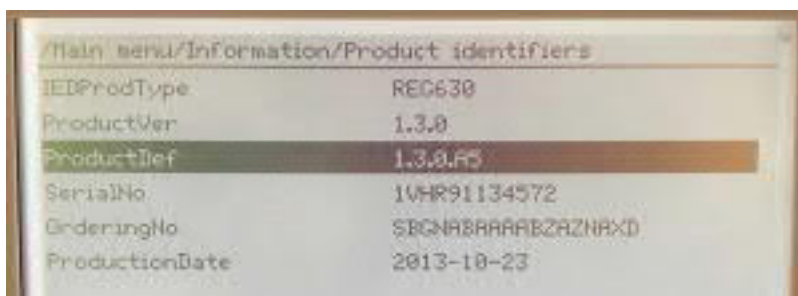
Fig. 2 Current firmware revision of the 630 series protection relay

To identify the current firmware revision of 630 series relays, please note the parameter **ProductDef**, refer to Figure 2.
