**TOTALFLOW**  
***Technical Bulletin 129***  
**BTU 8000 Flash Update Procedure**

**Totalflow Technical Bulletin**

Version 1.0, Revision AA (19 April 2005)

This document describes how to download a flash file into a BTU 8000/8100.

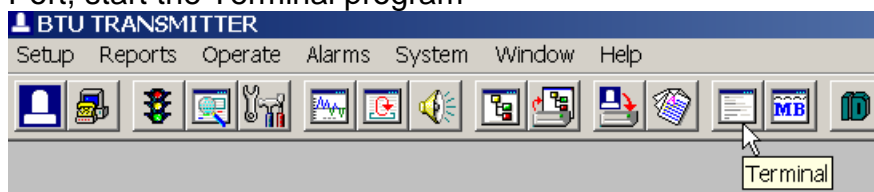
1. To determine if your BTU 8000/8100 Transmitter is running from Flash or from EPROM you can connect the local communications cable to the MMI Comm Port, start the Terminal program

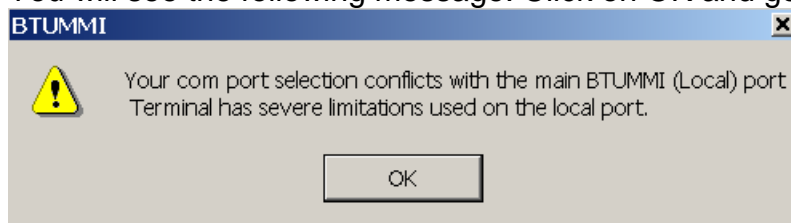
2. You will see the following message. Click on OK and go on.

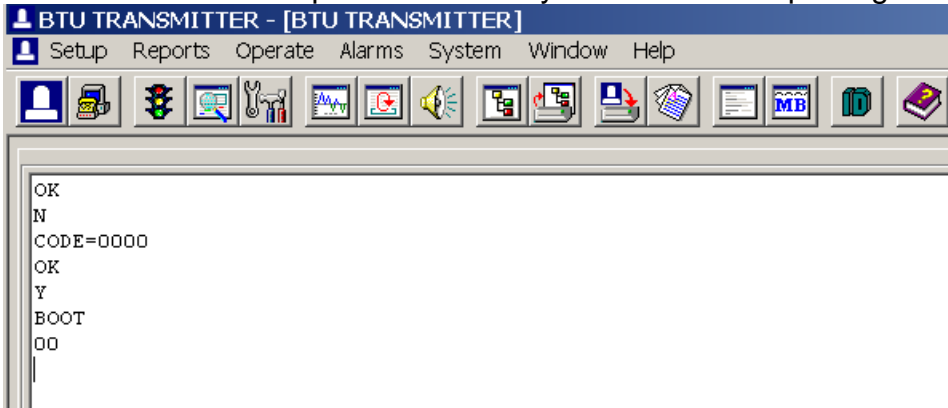
3. Type OK in capital letters. If the Transmitter responds with an N it means that you need to enter the security code. The default security code is four zeros. (0000). Type CODE=0000 (or your security code) and then type OK again. The transmitter should respond with a Y if you have access privileges.

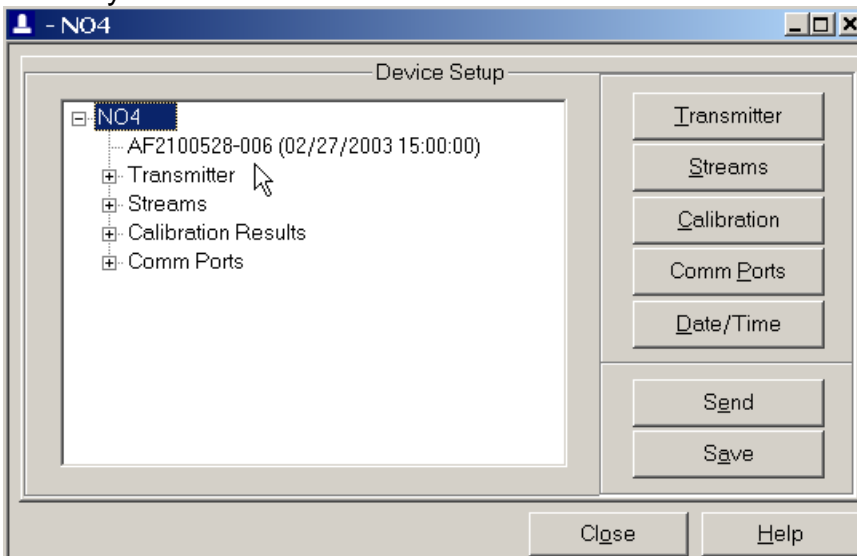
4. Next type BOOT. The unit will respond with a 00 if it last booted out of Flash memory or a 01 if it booted out of EPROM.
5. The current version of firmware will be listed on the Current results reports or can be seen on the setup screen underneath the Transmitters ID. This will, however, not tell you if the transmitter was started from flash or from EPROM.

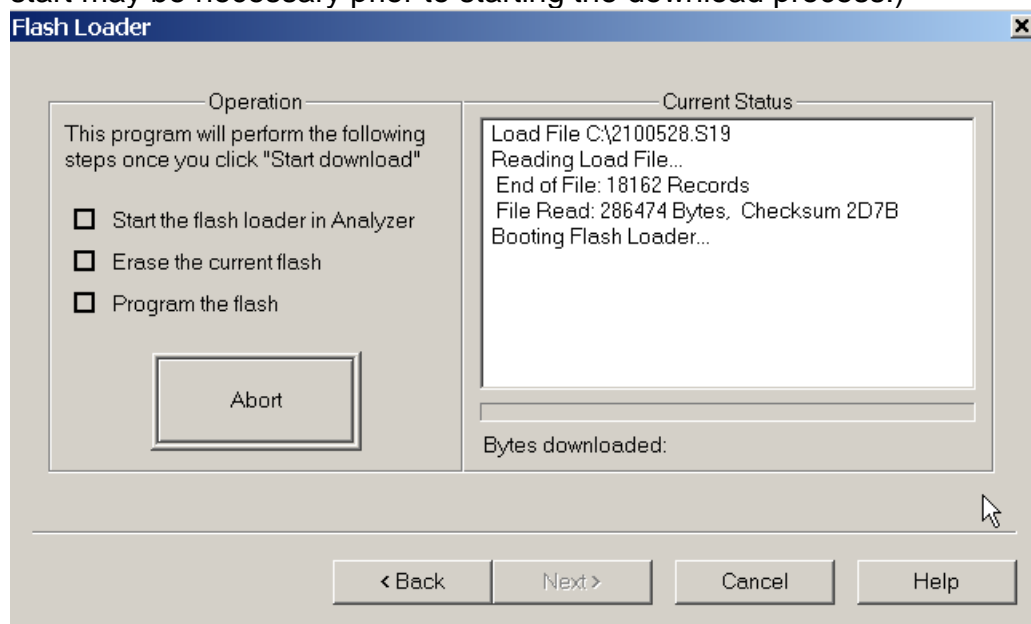
(If the Flash Loader in the BTU transmitter fails to start, it may be necessary to Warm start the BTU transmitter by turning the power off and back on. After the unit has been back on for at least 30 seconds, it should be possible to attempt the connection again. If this fails, you may need to abort the startup tests in the BTU Transmitter Startup Screen and try the download again. If this fails a Cold start may be necessary prior to starting the download process.)

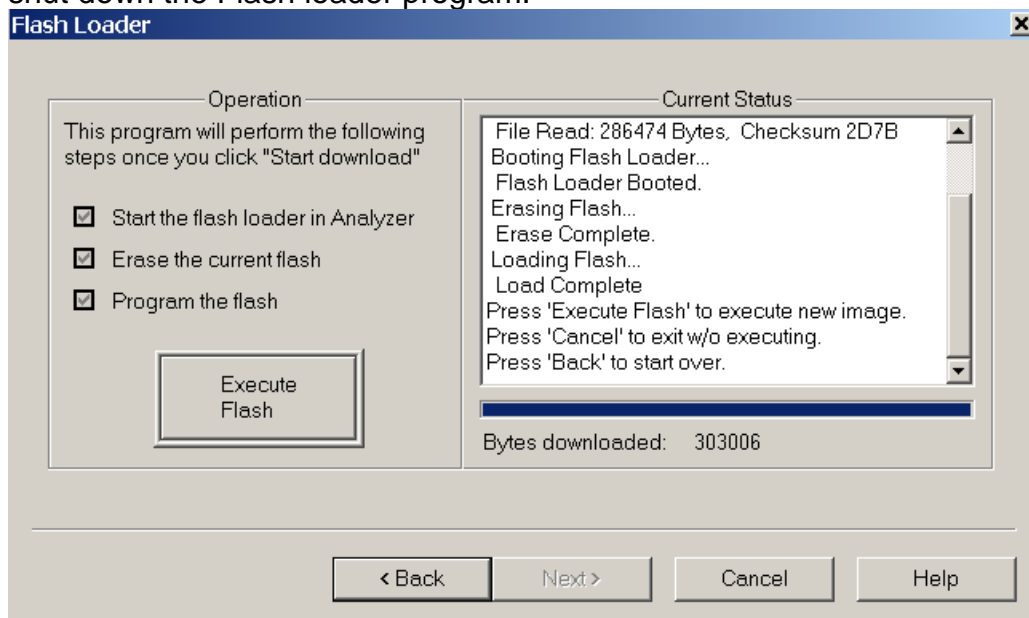
- When it is finished, an Execute Flash button will appear. Press the button and shut down the Flash loader program.
