Document class Release Note
Document ID 2NGA001880
Business Unit ABB Oy, Distribution Solutions
Page 1/6
Date 01.12.2023

Firmware update release 4.0.8 for 615 series IEC product version 4.0 protection relays

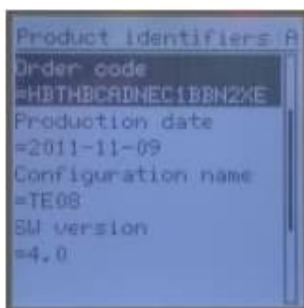
Fig. 2 Current firmware revision of the 615 series protection relay

To identify the current firmware revision of the 615 series protection relay, please refer to Fig. 2.
