Seeing through switchgear

Radiographic inspection saves costs and downtime and enables better maintenance planning

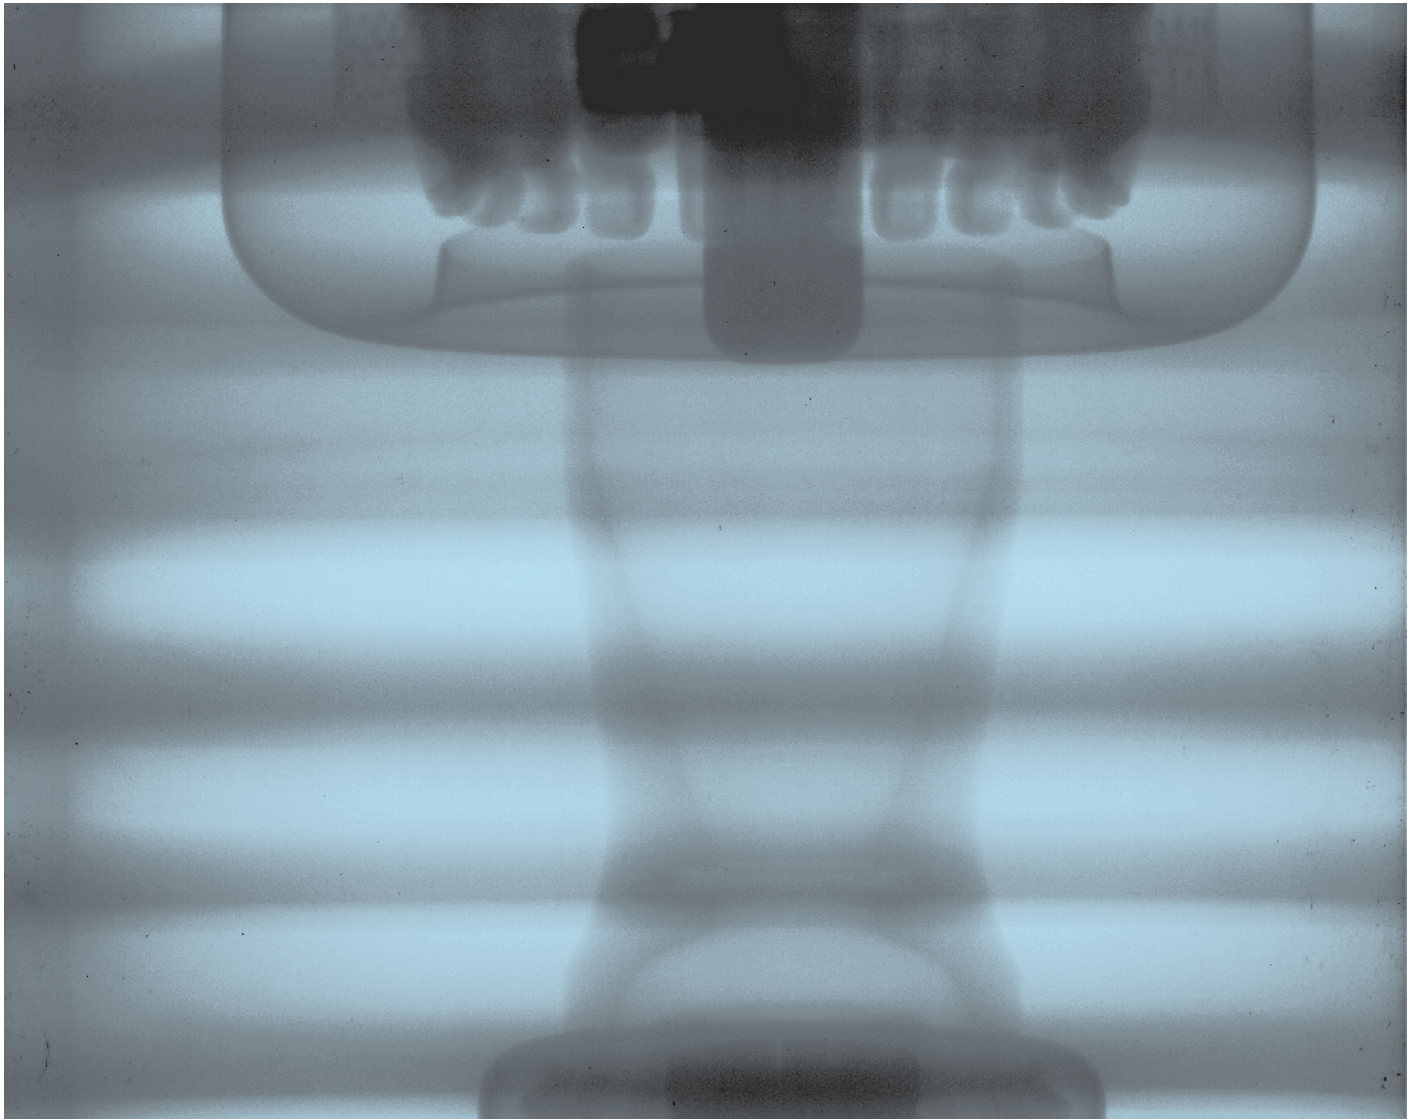
Title picture

Looking inside a breaker with radiography

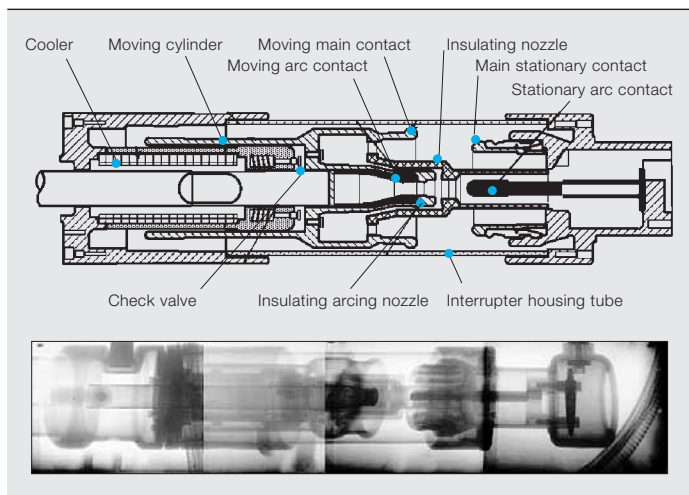
3 Comparison of radiographic images and a diagram of a 38/72 PM interrupter

A comparison between radiographic images and a diagram are shown in → 3. Examples of the level of detail such images can provide is shown in → 4. Experts can use such images to measure parts that are subject to wear. An “in spec” nozzle is compared with an “out of spec” one in → 5.

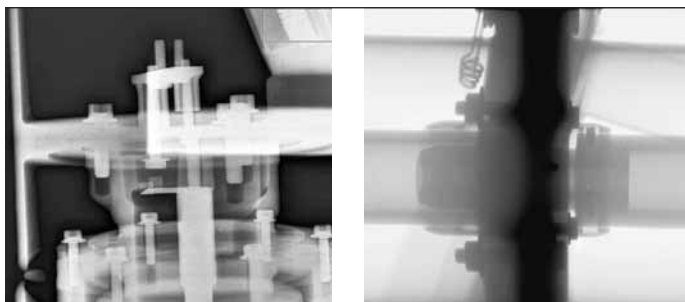
4 Examples of details revealed by radiography

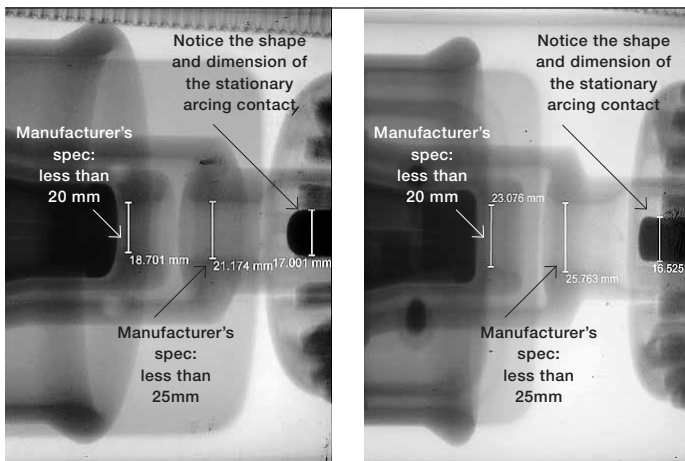
5 Comparing a “good” and a “bad” nozzle

5a Nozzle in spec

5b Nozzle out of spec

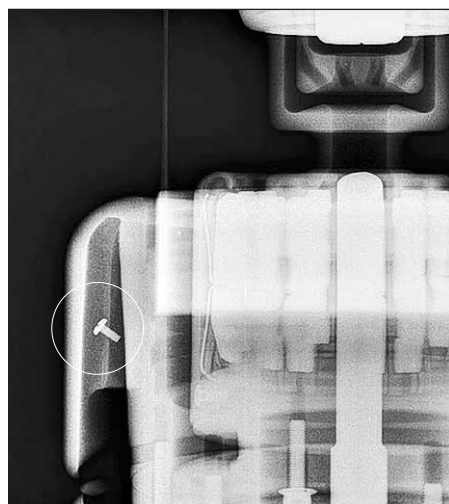
6 Detached screw

Besides problems associated to wear, radiography can also reveal manufacturing defects. In → 6, a detached screw can be seen, and in → 7, a bolt is incorrectly inserted.

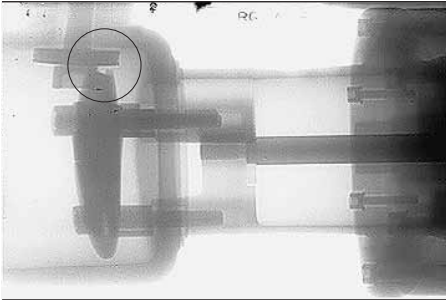
7 Incorrectly inserted bolt (note gap between disk and casing)

7a An area of concern

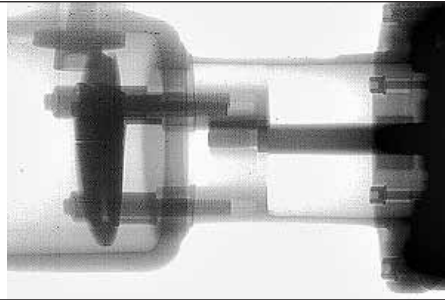
7b Correct bolt

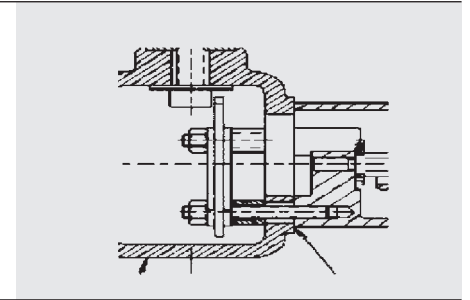
7c Reference drawing
