Document class      Release Note  
 Document ID        2NGA002360  
 Business Unit       ABB Oy, Distribution Solutions  
 Page                 1/5  
 Date                 16.09.2024

## Firmware update release 1.2.0.B8 for 630 series product version 1.2 protection relays

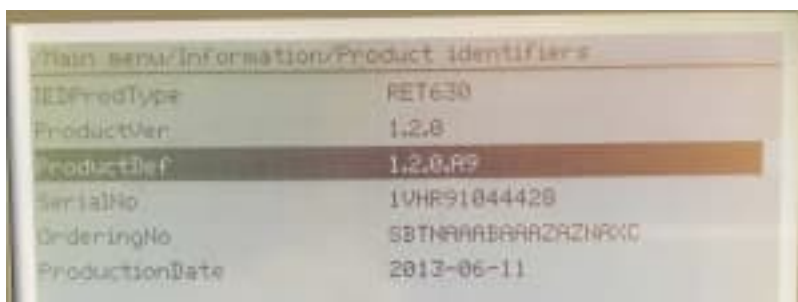
*Fig. 2 Current firmware revision of the 630 series protection relay*

To identify the current firmware revision of 630 series relays, please note the parameter **ProductDef**, refer to Figure 2.
