# CoreSense M10

## Release Notes

Software version 1.4.0.14

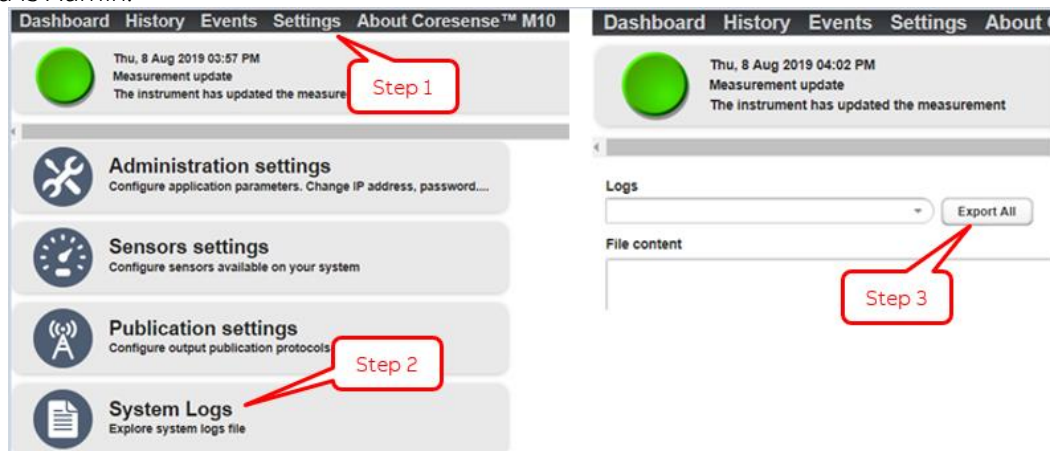
Figure 1. System logs.

1. Obtain the CoreSense M10 software images from ABB (see §1.1.3).
2. Open a web browser and enter the IP address of your system in the address bar. IP address is shown in the bottom of the CoreSense M10 local screen. Your computer must be configured in the same network subnet.
3. Click on **Settings** tab and then click on **System Logs**. Enter your password to gain access, factory password is *Admin*.

4. Click on **Export all**. A download should start. Save and keep the *.zip* file as it may help ABB service in case a problem occurs during the update.
5. Click on **History** and on **fgs**→**Acetylene** and then on **Export**. A download should start. Save and keep the *.csv* history file.

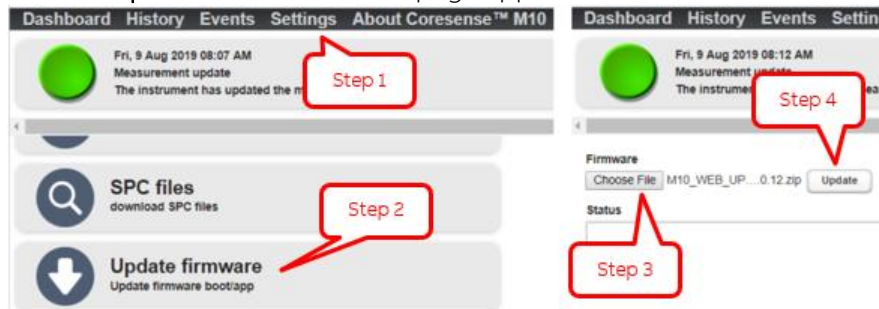
Figure 3. Update firmware.

6. Click on **Settings** and on **Update firmware**. A new page appears.

7. Click on **Choose File** and select the M10\_WEB\_UPDATE\_1.4.0.14.zip file. Click on **Open** and then on **Update**. The update process will start and can last for few minutes. Messages will appear in the **Status** pane during the process and “Rebooting instrument now” will appear at the end of the process. The update is complete once a “Session Expired” red banner appears on the top of the web page.

1. Click on **Settings** and on **Update firmware** (see Figure 3). A new page appears.
2. Click on **Choose File** and select the M10\_WEB\_H2SUpdate\_3.966J.zip file. Click on **Open** and then on **Update**. The update process will start and can last for few minutes. Messages will appear on the **Status** pane during the update process. It will be completed a few minutes after the “Rebooting instrument now” message. The update is complete once a “Session Expired” red banner appears on the top of the web page.

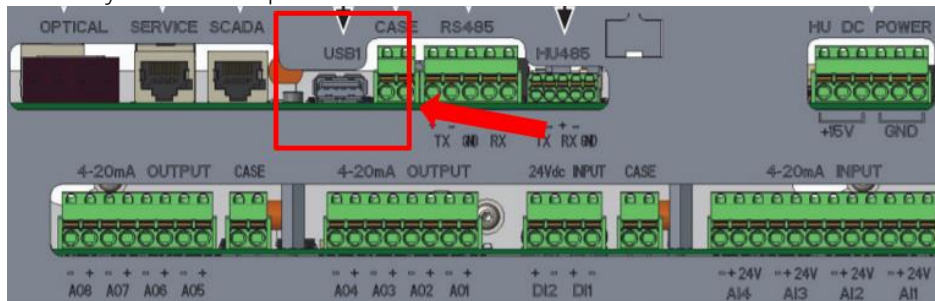
Figure 5. Instrument USB port.

5. Insert the first USB key on the USB port of the CoreSense M10 cabinet.

6. Turn on the instrument using the main power switch (see Figure 4). The update process will start automatically.
7. Messages will appear on the local screen during the update process lasting for a few minutes. The update process is complete when a message indicating to remove the USB key and to reboot appears.
8. After the “remove USB key and reboot” message appear on the screen, remove the USB key and power cycle the instrument.
9. A complete system update will be done after this step. During the process, the instrument may reboot two or three times depending on the required updates for your system. Wait until the dashboard page is displayed for at least 4 minutes. (The dashboard might be empty for the first 20 minutes).

1. On a **USB key**, extract M10\_USBkey\_H2SUpdate\_3.966J.zip making sure NOT to create a folder and to install at the root of the USB filesystem.
2. Shutdown the instrument using the main power switch (see Figure 4).
3. Insert the second USB key on the USB port of the CoreSense M10 cabinet (see Figure 5).
