Document class **Release Note**
Document ID **1MRS758731**
Business Unit **ABB Oy, Medium Voltage Products**
Page **1/2**
Date **30.09.2016**

Firmware update release 1.0.4 for 611 series IEC product version E protection relays

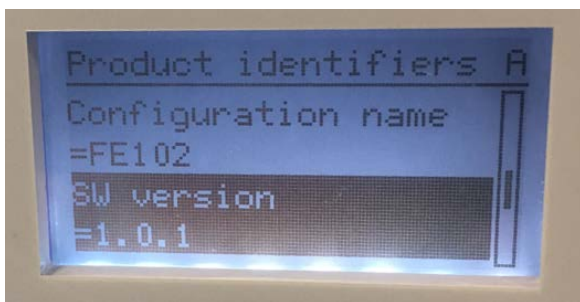
Fig. 2 Current firmware revision of the 611 series protection relay

To identify the current firmware revision of the 611 series protection relay, please refer to Fig. 2.
