Document class Release Note
Document ID 2NGA002090
Classification Public
Business Unit ABB Oy, Distribution Solutions
Page 1/7
Date (dd.mm.yyyy) 23.02.2024

Firmware update release 4.1.10 for 615 series IEC product version 4.0 FP1 protection relays

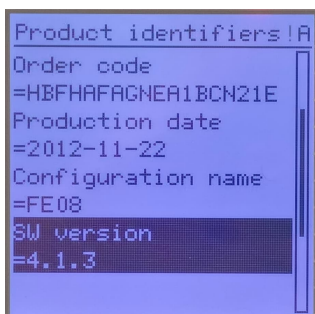
To identify the current firmware (SW) revision of the 615 series protection relay, please refer to Fig. 2.

Fig. 2. The firmware revision of the 615 series protection relay
