Document class	Release Note
Document ID	2NGA000649
Business Unit	ABB Oy, Distribution Solutions
Page	1/4
Date	23.09.2020

Firmware update release 1.2.0.B6 for 630 series product version 1.2 protection relays

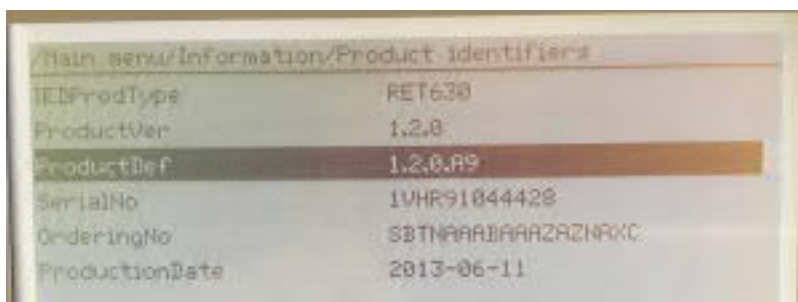
Fig. 2 Current firmware revision of the 630 series protection relay

To identify the current firmware revision of 630 series relays, please note the parameter **ProductDef**, refer to Figure 2.
