Document class      Release Note  
Document ID         2NGA000647  
Business Unit        ABB Oy, Distribution Solutions  
Page                 1/4  
Date                 23.09.2020

## Firmware update release 1.1.0.C3 for 630 series product version 1.1 protection relays

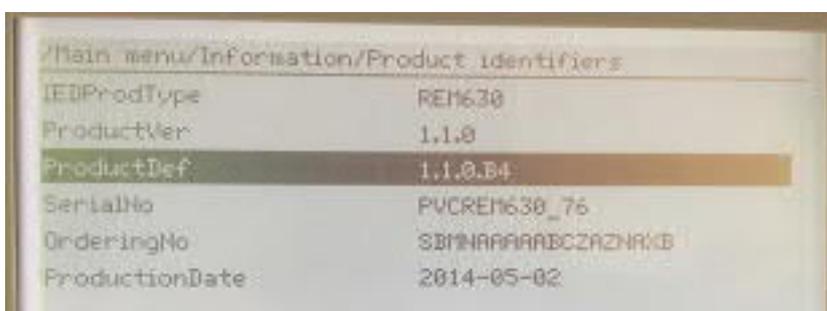
To identify the current firmware revision of 630 series relays, please note the parameter **ProductDef**, refer to Figure 2.

*Fig. 2 Current firmware revision of the 630 series protection relay*
