Document class Release Note
Document ID 2NGA001534
Business Unit ABB Oy, Distribution Solutions
Page 1/11
Date (dd.mm.yyyy) 18.10.2022

Firmware update release 1.0.8 for REX640 control and protection

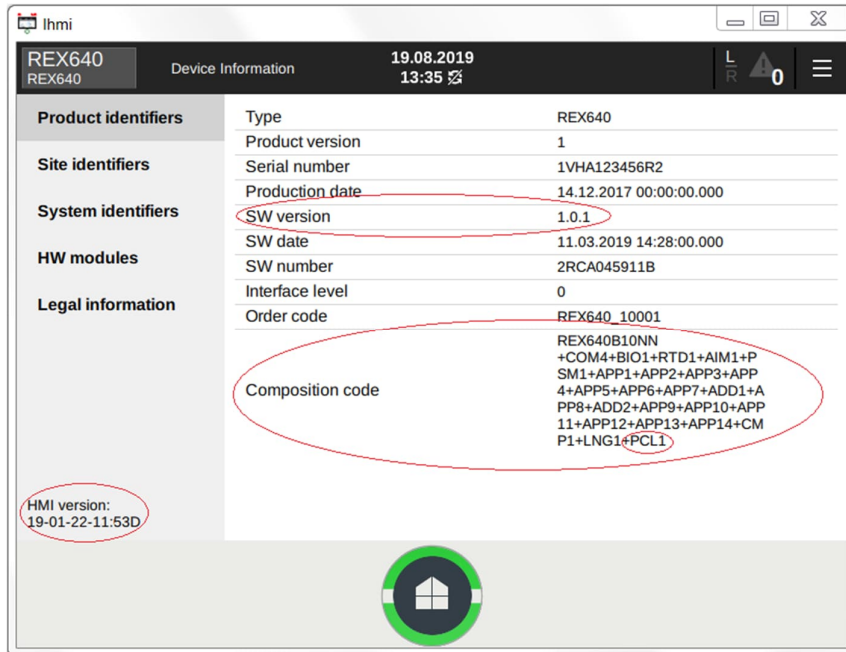
Fig 1. Lhmi Device Information page

Following figures show how to locate the above-mentioned information from the LHMI Device Information page and from the WHMI Product Identifiers page. The LHMI Device Information page can be accessed by tapping the menu bar on upper part of the LHMI screen and locating the Device Information button from the lower left-hand corner of the screen. The relay Firmware version is referred as "SW version" and the LHMI application version is referred as "HMI version". The "PCL" part of the composition code is pointed out as well.

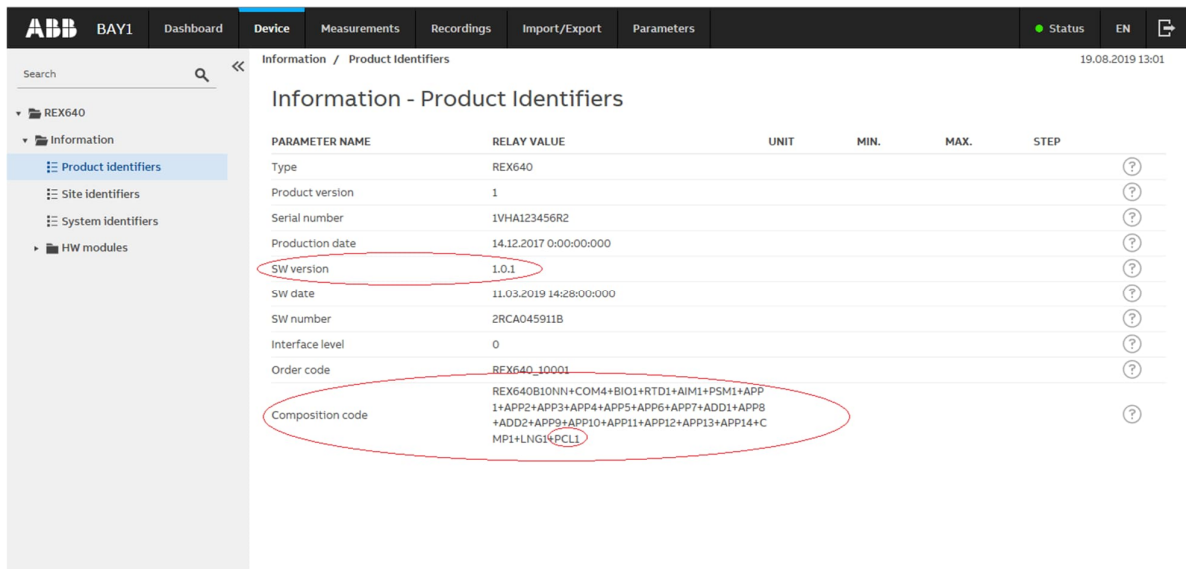
Fig 2. WHMI Product Identifiers page
