Document class Release Note
Document ID 2NGA002359
Business Unit ABB Oy, Distribution Solutions
Page 1/5
Date 16.09.2024

Firmware update release 1.1.0.C5 for 630 series product version 1.1 protection relays

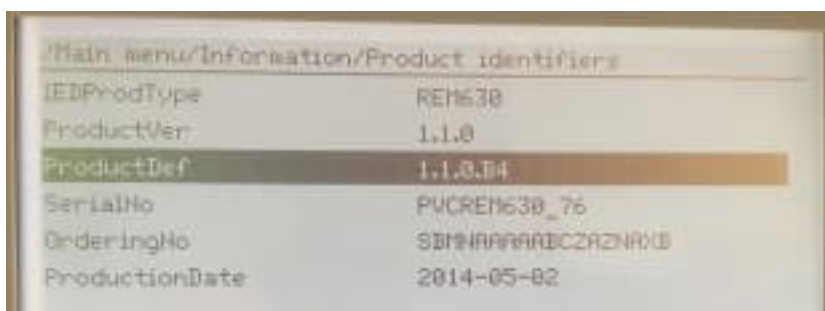
Fig. 2 Current firmware revision of the 630 series protection relay

To identify the current firmware revision of 630 series relays, please note the parameter **ProductDef**, refer to Figure 2.
