Document class Release Note
Document ID 2NGA002260
Classification Public
Business Unit ABB Oy, Distribution Solutions
Page 1/4
Date (dd.mm.yyyy) 28.05.2024

Firmware update release 1.1.4 for REC615 / RER615 protection and control relays

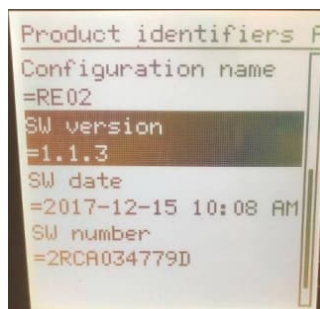
Fig. 2 The firmware revision of the REC615/RER615 control and protection relay

To identify the current firmware (SW) revision of the REC615 / RER615 protection and control relay, please Refer to Fig. 2.
