Document class Release Note
 Document ID 2NGA000125
 Business Unit ABB Oy, Distribution Solutions
 Page 1/8
 Date 17.07.2019

Firmware update release 2.1.10 for 620 series product version 2.0 FP1 (G) protection relays

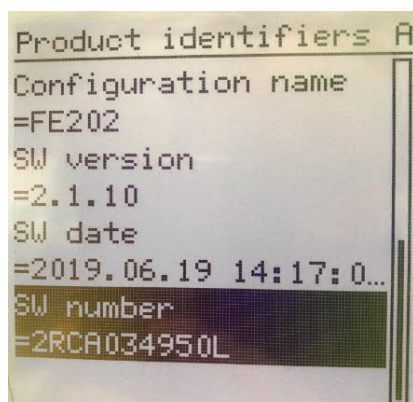
Fig. 2. The firmware revision of the 620 series protection relay

To identify the current firmware (SW) revision of the 620 series protection relay, please refer to Fig. 2.
