CoreSense M10

Release Notes – 0048-00-3-00005-01 Rev D

Software Version 1.4.0.18

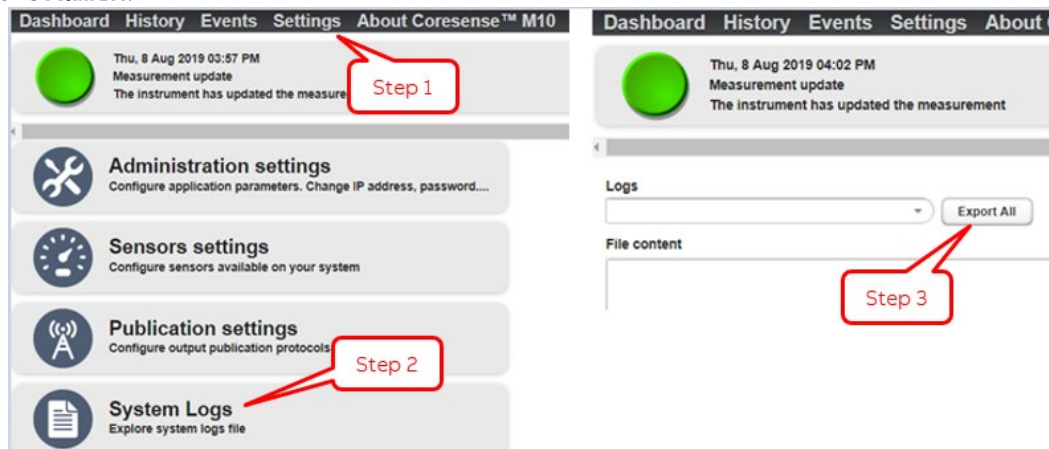
Figure 1. System logs.

1. Obtain the CoreSense M10 software images from ABB (see §2.1.3).
2. Open a web browser and enter the IP address of your system in the address bar. IP address is shown in the bottom of the CoreSense M10 local screen. Your computer must be configured in the same network subnet.
3. Click on the **Settings** tab and then click **System Logs**. Enter your password to gain access. The factory password is **Admin**.

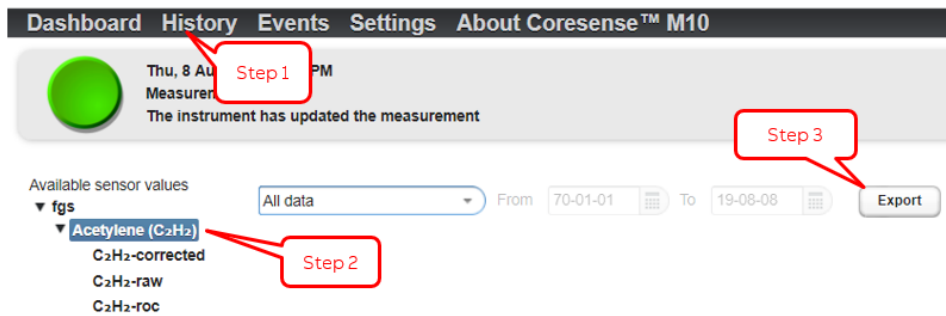
Figure 2. History.

4. Click **Export all**. A download should start. Save and keep the `.zip` file as it may help ABB service in case a problem occurs during the update.
5. Click **History** and **fgs**→**Acetylene**, and then **Export**. A download should start. Save and keep the `.csv` history file.

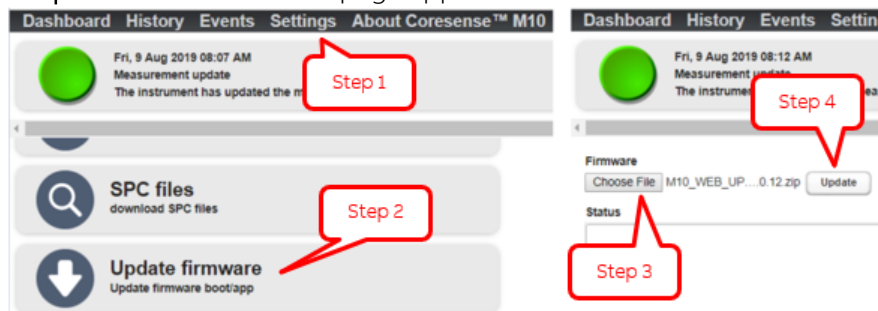
Figure 3. Update firmware.

6. Click **Settings** and **Update firmware**. A new page appears.

7. Click **Choose File** and select the `M10 WEB UPDATE 1.4.0.18.zip` file. Click **Open** and then **Update**. The update process will start and can last for few minutes. Messages will appear in the **Status** pane during the process and “Rebooting instrument now” will appear at the end of the process. The update is complete once a “Session Expired” red banner appears on the top of the web page.

1. Click **Settings** and **Update firmware** (see Figure 3). A new page appears.
2. Click **Choose File** and select the M10 WEB H2SUpdate 3.966J.zip file. Click **Open**, and **Update**. The update process starts and can last for few minutes. Messages will appear on the **Status** pane during the update process. It will be completed a few minutes after the “Rebooting instrument now” message. The update is complete once a “Session Expired” red banner appears on the top of the web page.
