Document class	Release Note
Document ID	2NGA000203
Business Unit	ABB Oy, Distribution Solutions
Page	1/6
Date	23.10.2019

## Firmware update release 1.0.4 for REX640 control and protection, including new application version for LHMI

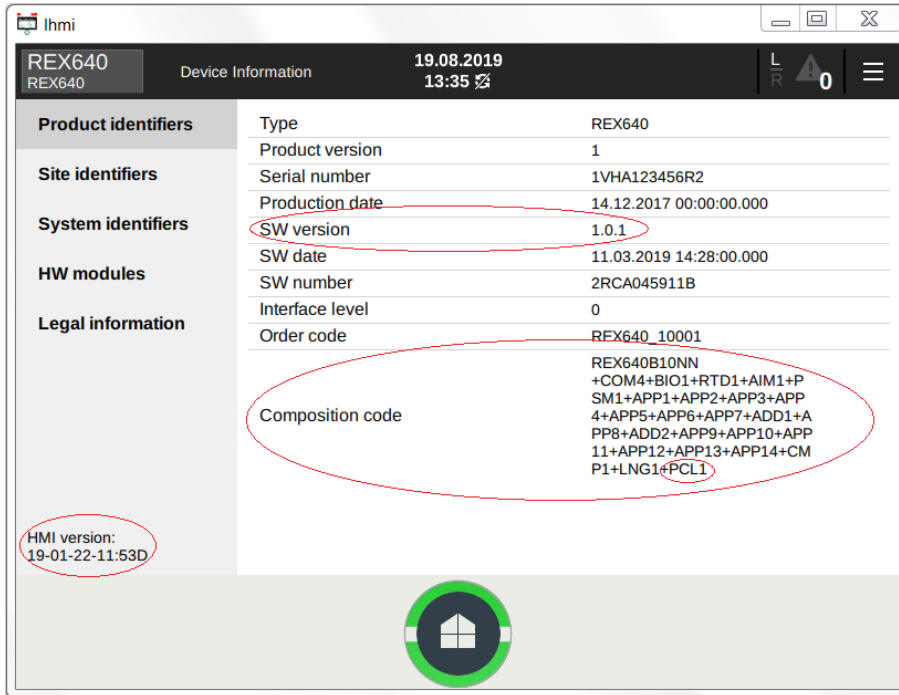
Fig 1. Lhmi Device Information page

Below figures show how to locate the above-mentioned information from the LHMI Device Information page and from the WHMI Product Identifiers page. The LHMI Device Information page can be accessed by tapping the menu bar on upper part of the LHMI screen and locating the Device Information button from the lower left-hand corner of the screen. The relay Firmware version is referred as "SW version" and the LHMI application version is referred as "HMI version". The "PCL" part of the composition code is pointed out as well.
